HARADA HOUSE

**3356 Lemon Street
Riverside, CA 92501**

April 30, 2018

STRUCTURAL ENGINEERING ASSESSMENT REPORT

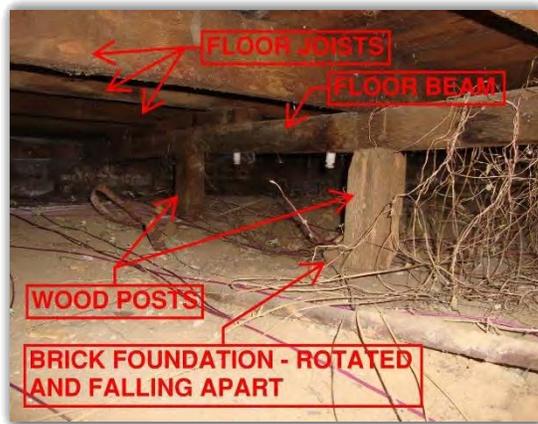
The Foundation System is the base of the structure and is the critical component for supporting all levels of a building. The Harada House is supported on wood posts on individual concrete and small brick pad foundations (spread footings) at the building interior in the crawl space (see Figure 4 below) and on straight line brick foundations (linear strip footings) around the perimeter of the building. A partial cellar was reportedly excavated in about 1915 and a new concrete foundation wall was constructed at that time. Figure 5 below shows the severely cracked concrete cellar wall located at the south-west corner of the house.

Figure 4 - Crawl Space Framing
(June 20, 2017)

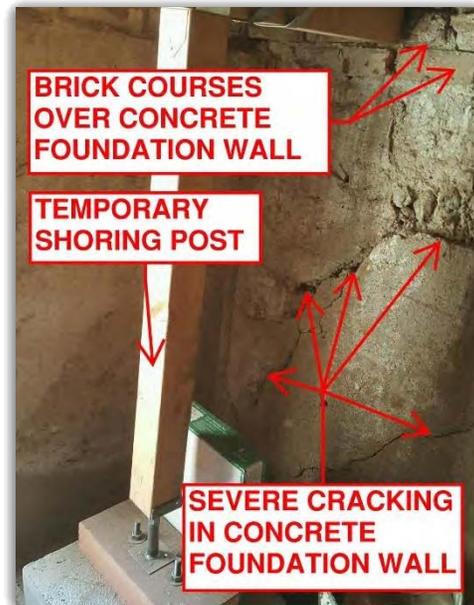
Figure 5 - Cellar Foundation Wall
(July 27, 2016)

- The concrete retaining wall in the cellar in the southwest corner on the south wall is leaning several inches into the building and has cracked severely in several locations, including one major horizontal crack at about half-height. The brick wythes on top of the retaining wall have rotated outward due to the weight of the wood stud wall on top. It appears that the much of the foundation damage is due to the lack of adequate drainage around the building leading to excessive water infiltration under and through the foundation walls into the crawlspace and cellar. Temporary shoring to prevent further damage at this location has been designed and installed. Shoring is exterior as well as interior. The exterior shoring also functions as a “cricket” that diverts rain and surface water away from the area in an effort to reduce hydrostatic pressure.

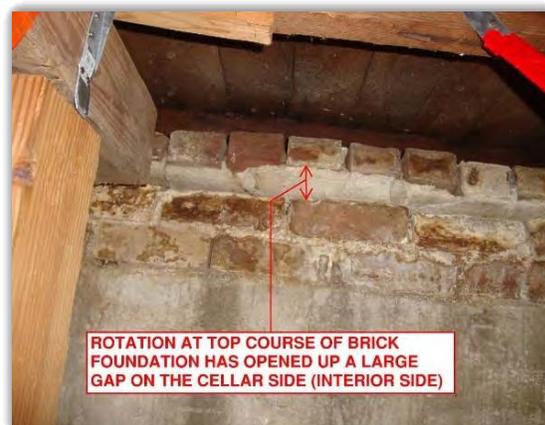
Although not verified with exploratory excavation, it appears that the perimeter wall foundations consist of double wide (two wythes) unreinforced brick. The depth of the brick foundation walls is unknown. The 2x wood sill plate typically bears on the top of the brick and the floor joists bear on the sill plate. The wall studs bear on the floor plate over the ends of the floor joists. There is typically no rim joist or blocking between the floor joists at the Ground Floor. There is no anchorage of the framing to the foundations. The condition of the brick foundation as observed from the interior side at the southwest corner cellar is very poor. The mortar joints are very soft and the bond between the bricks and mortar has released. The top course of brick on the south wall of the cellar have rotated and displaced due to rotation of the concrete retaining wall below. See Figure 6 for a photo of this condition.

Figure 6 - Rotated Brick Foundation below South Wall
(June 20, 2017)

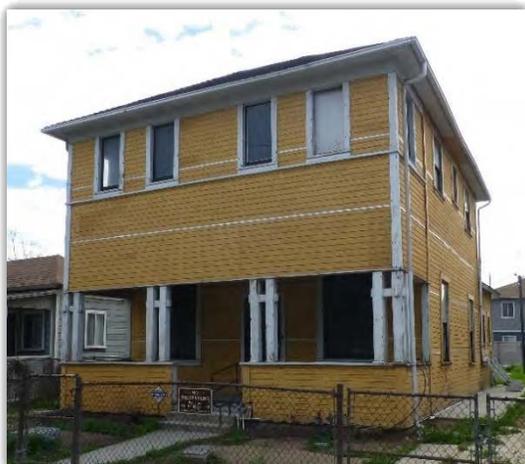
The original vertical lateral force resisting elements consist of the existing 2x4 wood stud walls. The interior walls are covered with wood lath and plaster on both faces, and the exterior perimeter walls have lath and plaster on the interior face and 1x horizontal clapboard siding on the exterior face. As part of this Structural Assessment project, the original siding was removed and replaced with plywood sheathing as shown in Figure 7 at the left. There is little

*Figure 7: Harada House with Plywood Sheathing
(March 20, 2018)*

blocking between joists and plates at the floor levels and no mechanical connections observed other than some occasional toenails. The interior walls do not bear on foundations so the lateral loads transfer horizontally through the diaphragms to the perimeter walls. The perimeter wall framing is not anchored to the perimeter brick foundations that are in a state of disrepair.

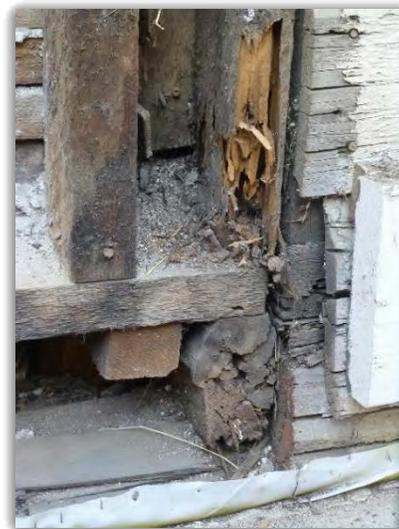
- a. Severe damage was found at the base of the wall on the south elevation in the middle portion of the house. The damage included deteriorated wood framing from termites, dry rot, and water damage (Figure 8 at right). In addition, the removal of the siding exposed a framing condition where load bearing studs were only supported by the bottom plate of the wall. This is not an adequate way to properly support wall studs

Figure 10 - South Wall Deteriorated Wood Framing (November 9, 2017)

The **Immediate Future category** repair for this condition was addressed with the implementation of sketch *SSK-1 Blocking at Base of Zone SIC*. The sketch can be found at the end of this report and provided new wood blocks at the base of the wall to provide direct support between load bearing exterior wall studs and the existing brick foundation. A permanent solution to this structural deficiency will be addressed with the construction of a new foundation for the building.

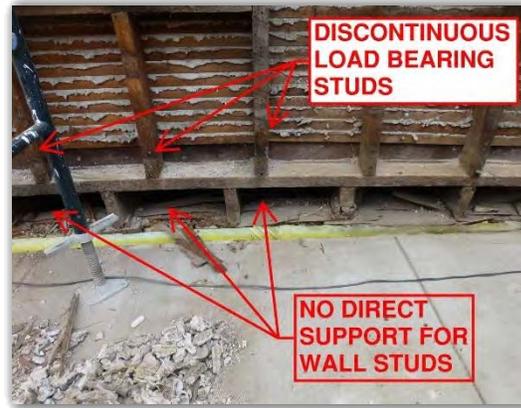
and is known as a discontinuous load bearing condition (Figure 9 at right).

Figure 11 - South Wall Discontinuous Load Bearing Condition (November 9, 2017)

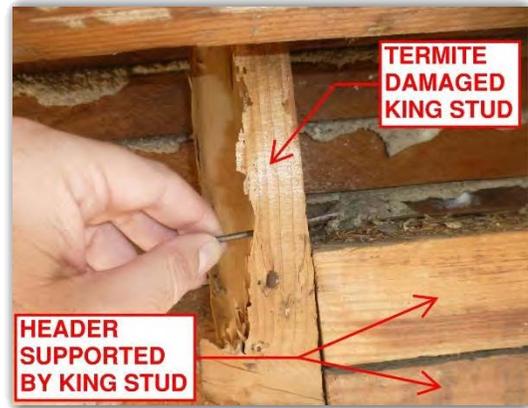
- d. Severe termite damage was found in two studs that support the south-east corner of the high roof. The most severely damaged stud was a header support stud (called a king stud) on the south side of the second-floor window. Approximately half of the stud width had been eaten away by termites, and the remaining portion of the stud was so compromised a nail could be pushed completely through with a bare hand. The photo at the right (Figure 12) shows this stud.

Figure 12 - Severely Compromised King Stud (November 29, 2017)

The repair for this condition involved replacing the severely damaged stud with a new stud. **Immediate Future** category repair SSK-5 Stud Replacement at Zone E2A shows the most severely damaged wood stud on the south side of the Second Floor window was removed and replaced with a new stud. The next stud to the south was supplemented by screwing a new stud to the side of the damaged one.

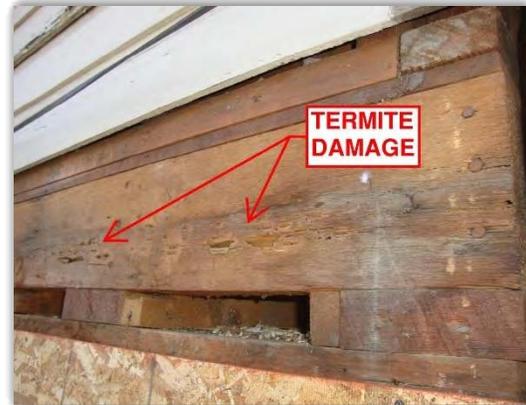
- e. The north elevation had two conditions that required immediate repair measures. The bottom plate of the ground floor wall was so badly damaged by termites that support for the north wall was compromised. In addition, the ground floor joist tails were irregularly framed and needed to be modified to facilitate the repair. At the second floor, the rim joist contained severe termite damage as well. Figure 12 and Figure 13 at the right show the extent of the damage.

Figure 13 - Second Floor Rim Joist with Termite Damage (December 7, 2017)

Two **Immediate Future** category repair sketches were issued to address the inadequate framing on the north elevation: SSK-6 Temp Repair at North Wall Bottom Plate and SSK-7 North Wall 2nd Floor Rim Joist. The bottom

plate of the ground floor wall was replaced, and the ground floor joist tails were supplemented with a new 2x joist screwed to the side and then trimmed to facilitate the repair. At the Second Floor, the rim joist was replaced.

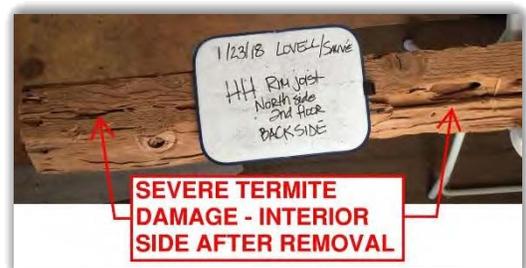
Figure 14 - Back side of Second Floor rim joist after being removed (January 23, 2018)

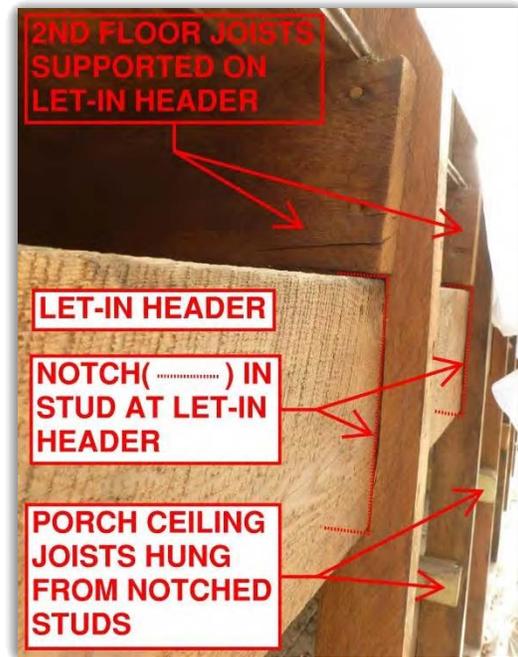
- i. The second-floor header on the west elevation contained a problematic framing condition. The header was originally built as a let-in 2x header creating a notch in the studs that the porch ceiling joists hang from. Figure 15 illustrates this condition.

Figure 15 - Porch Ceiling Joists Hung from Notched Studs (January 16, 2018)

This condition was mitigated by SSK-11 *Detail at (E) Let-In Header (West Elevation)* as an **Immediate Future** category repair. The detail adds new posts from the foundation of the west elevation to the roof, special detailing was required to pass around the existing let-in header at the second-floor.

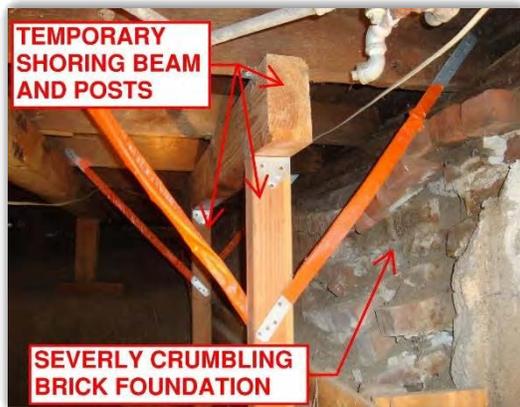
5. The original brick and concrete basement foundations are severely damaged and need to be replaced. In addition to the most visible damage at the south-east corner of the house in the partial cellar (see Figure 16 and Figure 17 below), there are loose bricks in several areas around the entire perimeter of the house.

Figure 16 – Crumbling Foundation below East Wall (June 20, 2017)

The Foundation System is the base of the structure and is the critical component for supporting all levels of a building. New code compliant foundations are needed to properly support the Harada House and anchor the wood framed building to the foundation. Structural Focus previously completed construction documents for new foundations to support the house, but the documents will need to be updated to include leveling the house. Replacing the foundation system will require a specialty contractor that can provide temporary support for the house and lift it to allow for construction of the new foundation system. The process will be a complex and risky undertaking that will likely involve major excavation work under the house. Figure 18 shows an example of a different historic house in Claremont, CA that was lifted and relocated on a new foundation. The photo is taken during construction when the holes for the new foundation were dug and steel reinforcing bars have been placed in the excavation in preparation for placement of new concrete foundations.

- Our recommendation for the Harada House is to construct the new foundation level and set the house on the foundation to restore the house back to a level condition. This will require removal of some of the temporary immediate repair work that was done in order to allow the house to properly sit on the new foundation. While time is of the essence when it comes to stabilizing the house on a proper foundation, this recommendation falls under the **Permanent Solution category**.

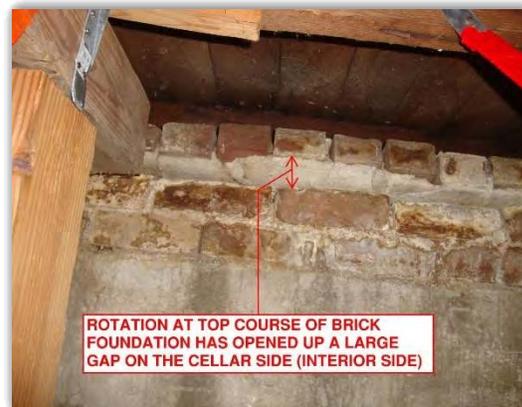
Figure 17 – Unstable Brick Foundation below South Wall (June 20, 2017)

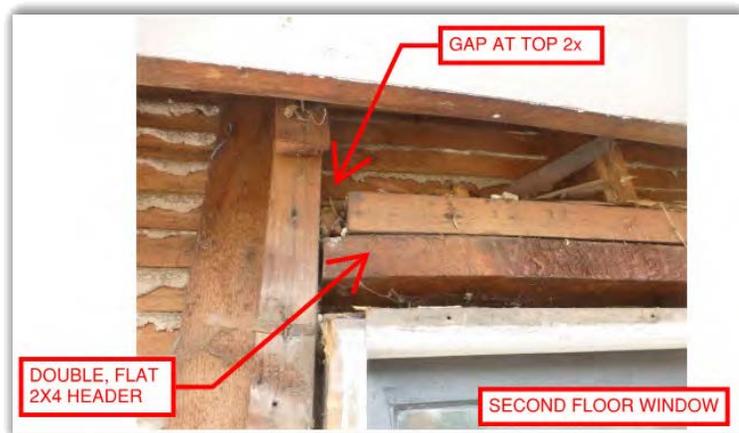
- a. Several poorly framed header conditions were found throughout the exterior walls. The headers often consist of a double, flat 2x4 that is end nailed to the closest adjacent stud. In some cases, the header is a single, flat 2x member. Figure 19 shows a typical header condition in the house.

Figure 19 - Harada House Typical Header Condition (November 6, 2017)

The **Permanent Solution category** repair for this condition is to remove the existing header and replace it with a properly designed and connected header. Modifications to the adjacent king studs as well as the addition of jack studs will also be required. Figure 20 shows a properly framed header condition using current construction practices.

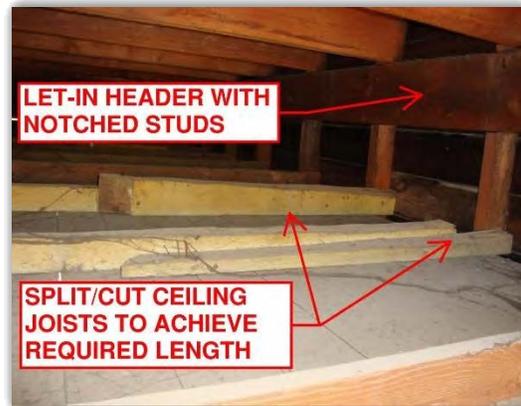
- c. The framing for the front porch is severely deteriorated and poorly laid out. It does not properly support the second-floor sleeping porch. The porch ceiling appears to be framed with ceiling joists that were made from scrap wood on site at the time the ceiling was built. This is a dangerous condition. Several of the joists are short and have been split for splicing another member alongside to span the required length. This condition can be seen in Figure 21 at the right.

Figure 21 - Inadequate Porch Ceiling Framing
(December 7, 2017)

Rebuilding the front porch and the ceiling over the front porch is a necessary **Permanent Solution category** repair. Until this can be done, access to the space over the porch ceiling should be restricted.

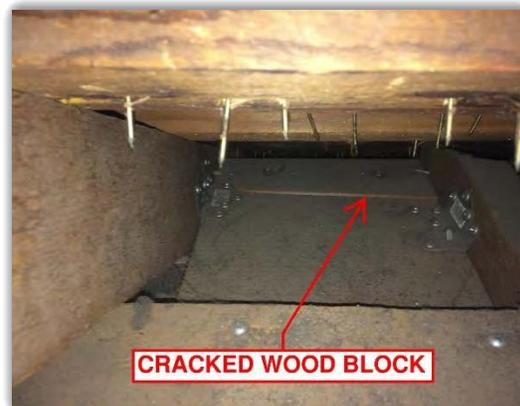
7. Cracked Wood Blocks in Attic - As part of the re-roofing project completed in 2006, horizontal wood blocks were added to properly connect the new plywood sheathing on the second-floor ceiling joists with the top plate of the perimeter walls. While assessing the condition of the house, it was observed that several of the blocks had cracked through the length of the block at the south-east corner of the house and along the north wall at the east end. Figure 22 shows this condition.

Figure 22 - Cracked Wood Blocking

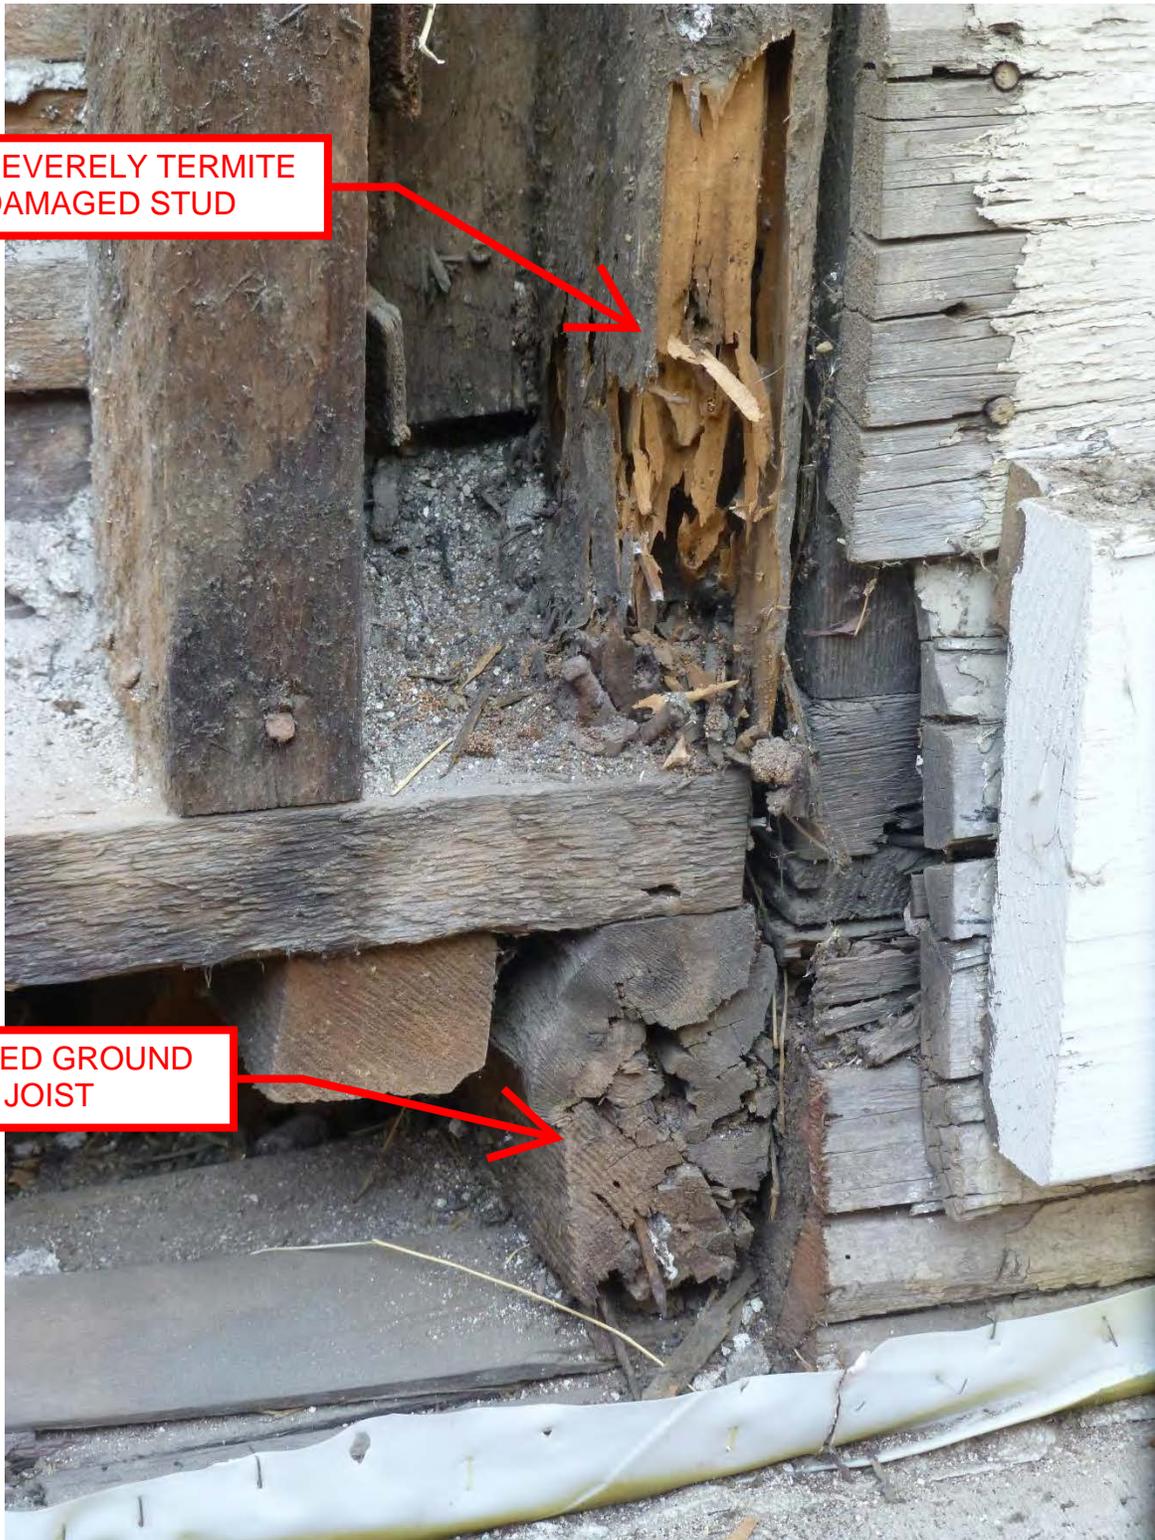
PHOTO 1: SOUTH ELEVATION – GROUND FLOOR

**SEVERELY TERMITE
DAMAGED STUD**

**CRUSHED GROUND
FLOOR JOIST**

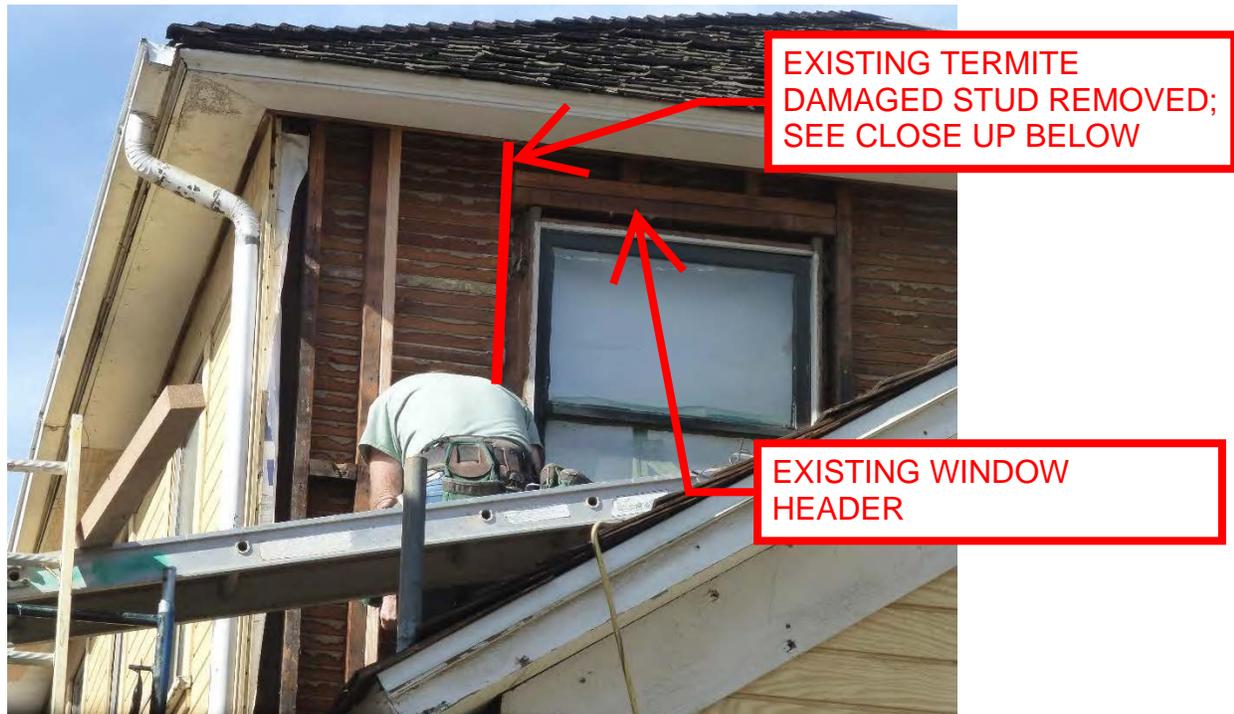
PHOTO 2: EAST ELEVATION – SECOND FLOOR

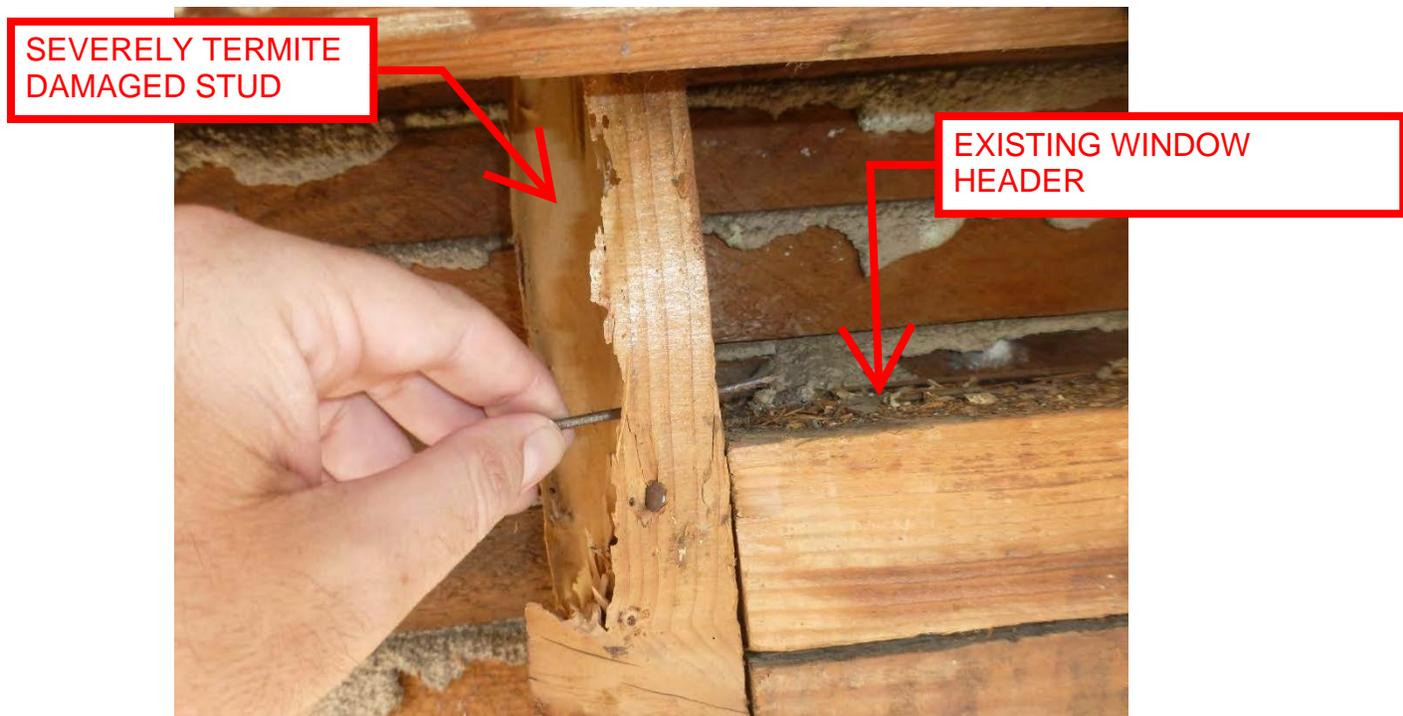
PHOTO 3: EAST ELEVATION – DAMAGED STUD

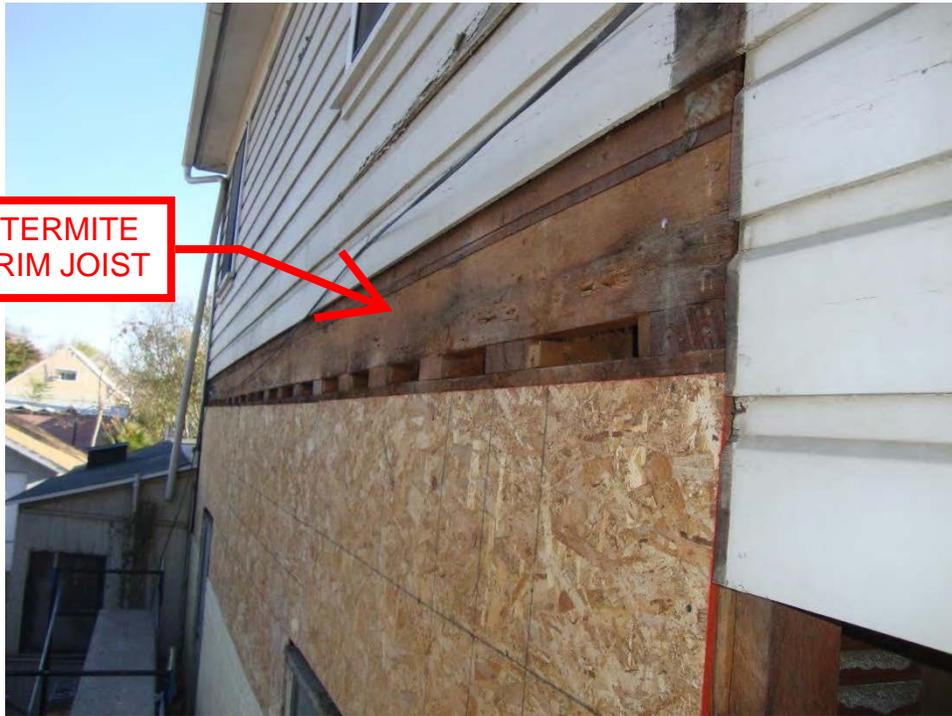
SEVERELY TERMITE
DAMAGED RIM JOIST

PHOTO 4: NORTH ELEVATION – 2ND FLOOR RIM JOIST

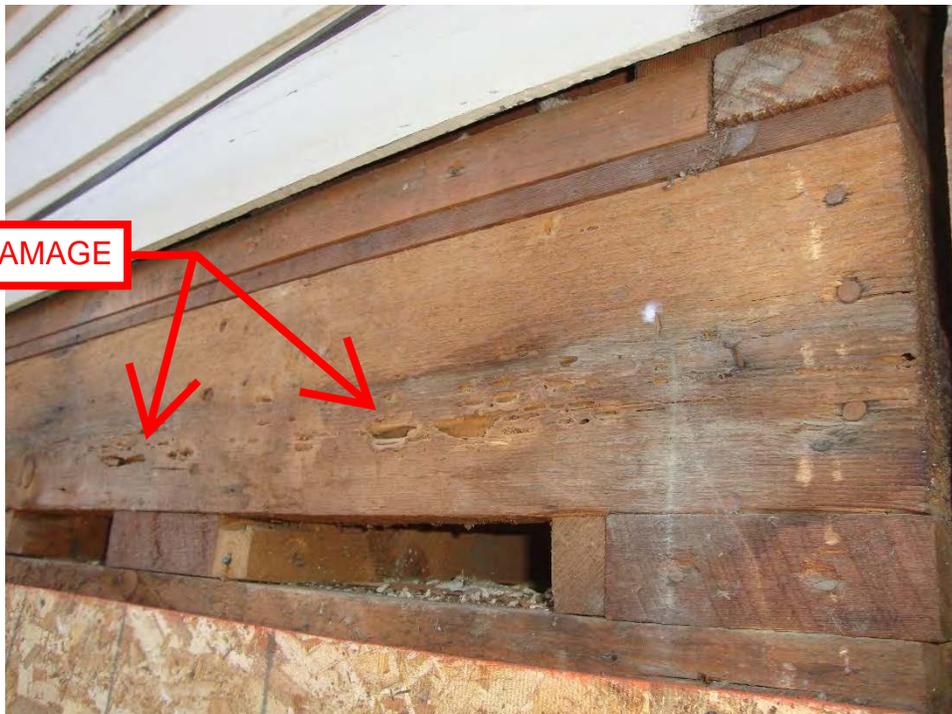
TERMITE DAMAGE

PHOTO 5: NORTH ELEVATION – DAMAGED RIM JOIST

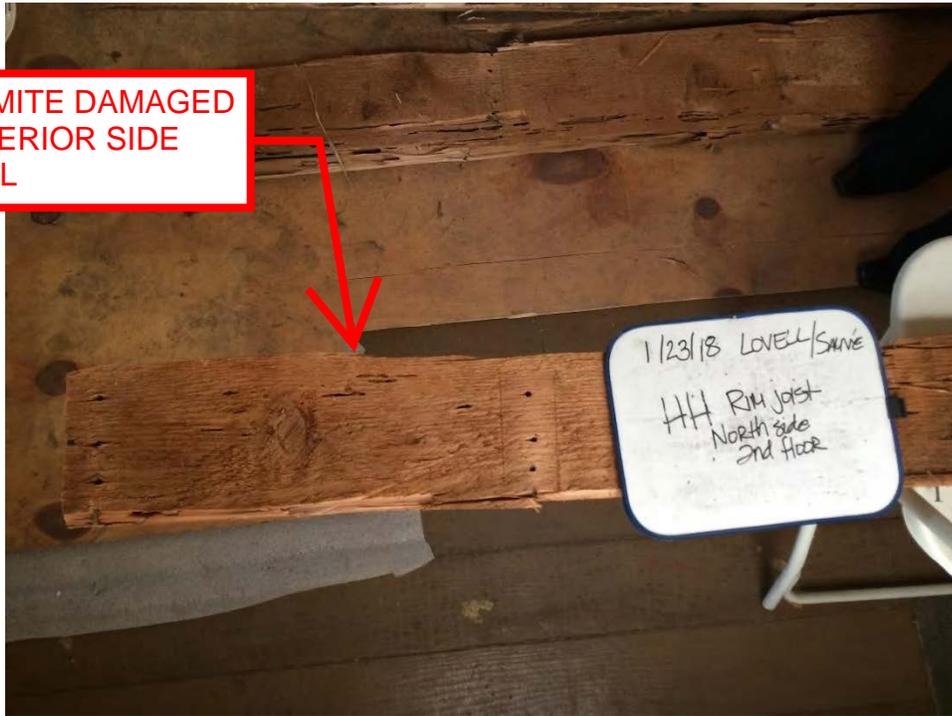
SEVERELY TERMITE DAMAGED
RIM JOIST - EXTERIOR SIDE
AFTER REMOVAL

PHOTO 6: NORTH ELEVATION – DAMAGED RIM JOIST

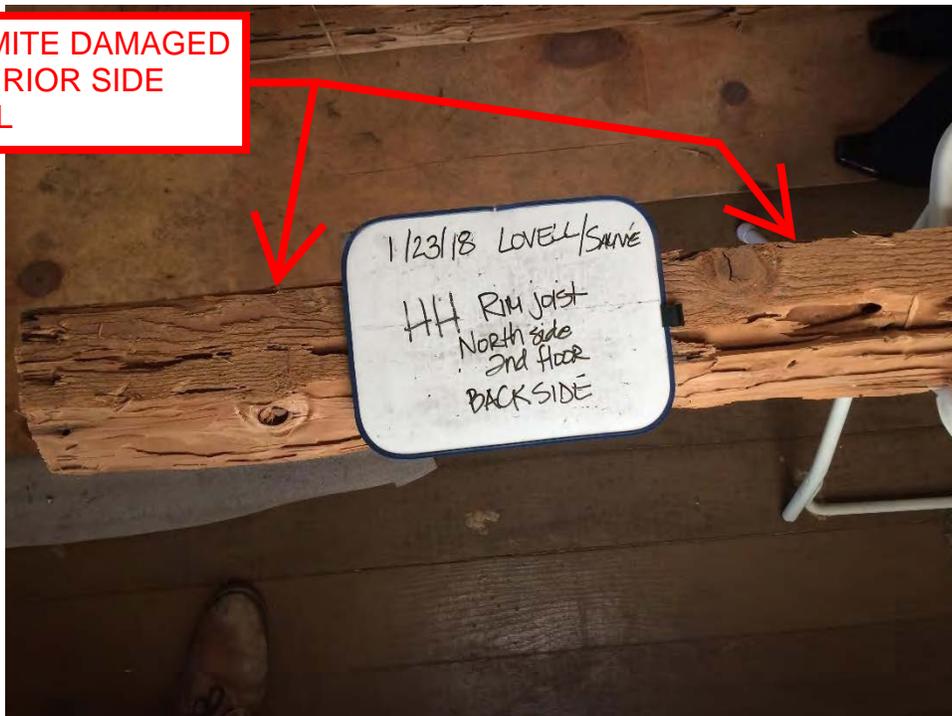
SEVERELY TERMITE DAMAGED
RIM JOIST - INTERIOR SIDE
AFTER REMOVAL

PHOTO 7: NORTH ELEVATION – DAMAGED RIM JOIST

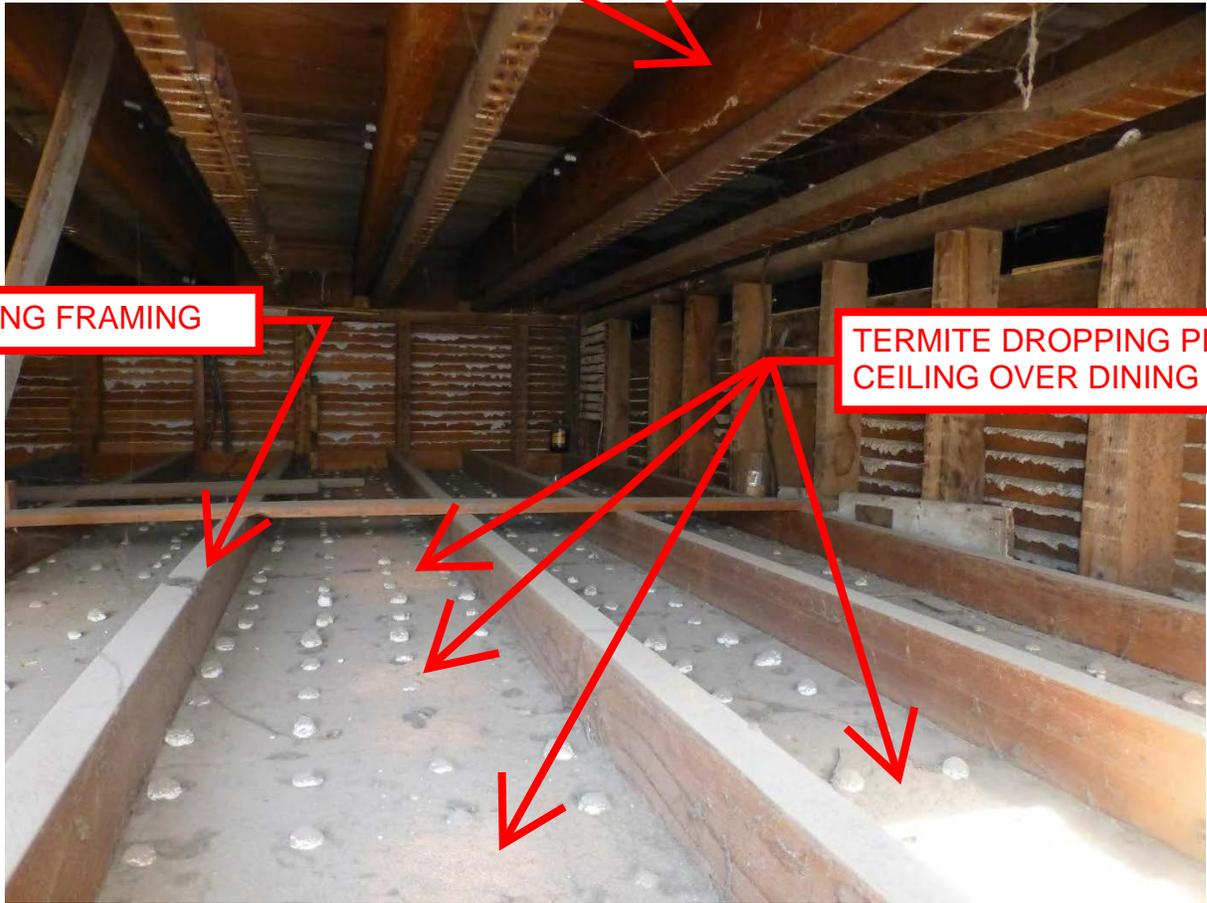
PHOTO 8: DROP CEILING OVER DINING ROOM
(MIDDLE OF HOUSE ON SOUTH SIDE)

TERMITE DROPPING PILES ON CEILING OVER DINING ROOM

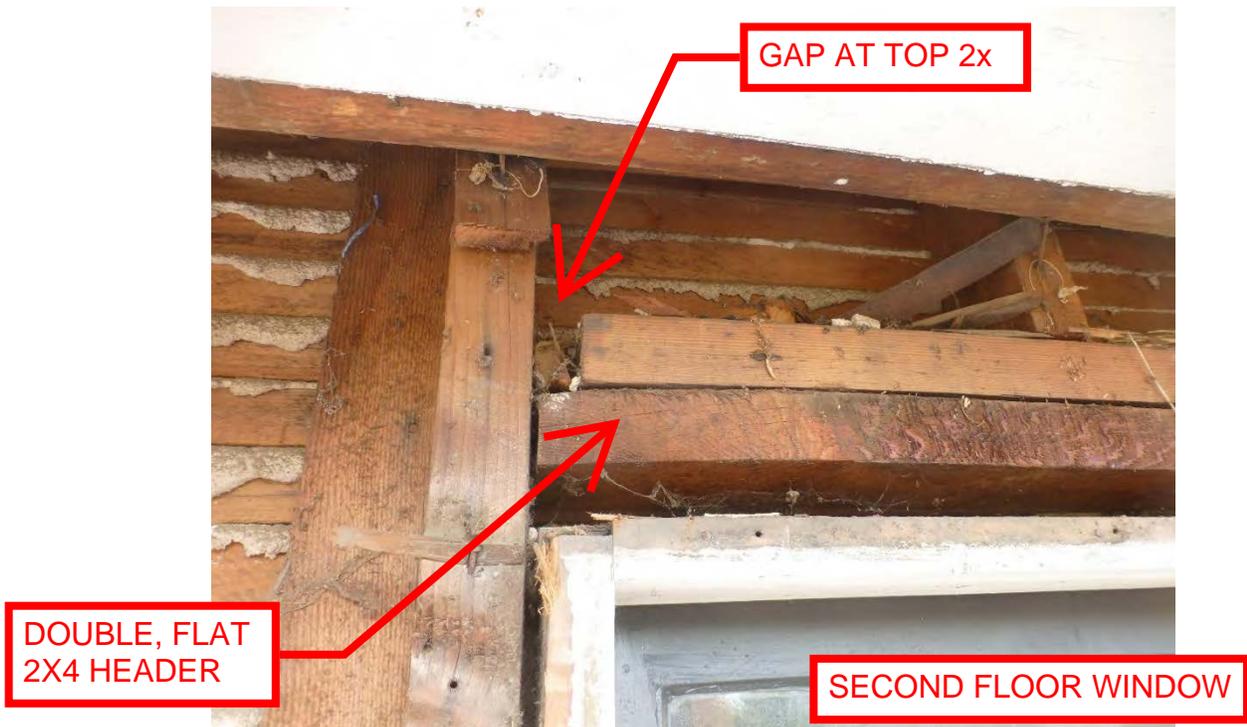
PHOTO 9: SOUTH ELEVATION – HEADER CONDITION

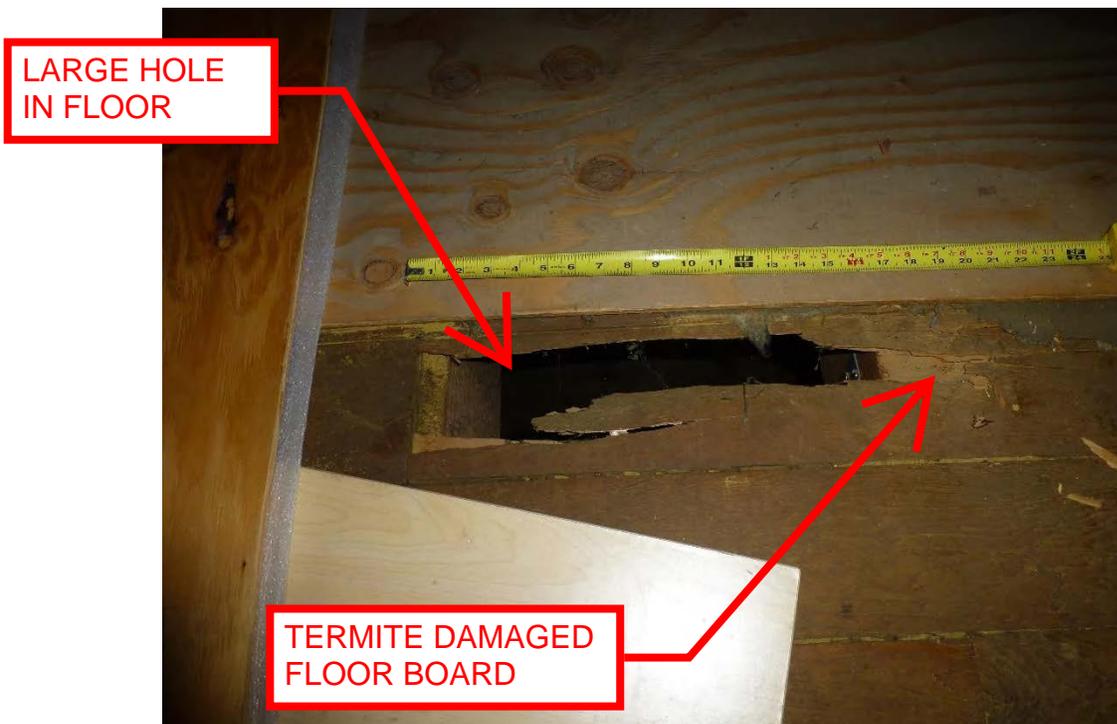
PHOTO 10: DINING ROOM – HOLE IN FLOOR BOARD

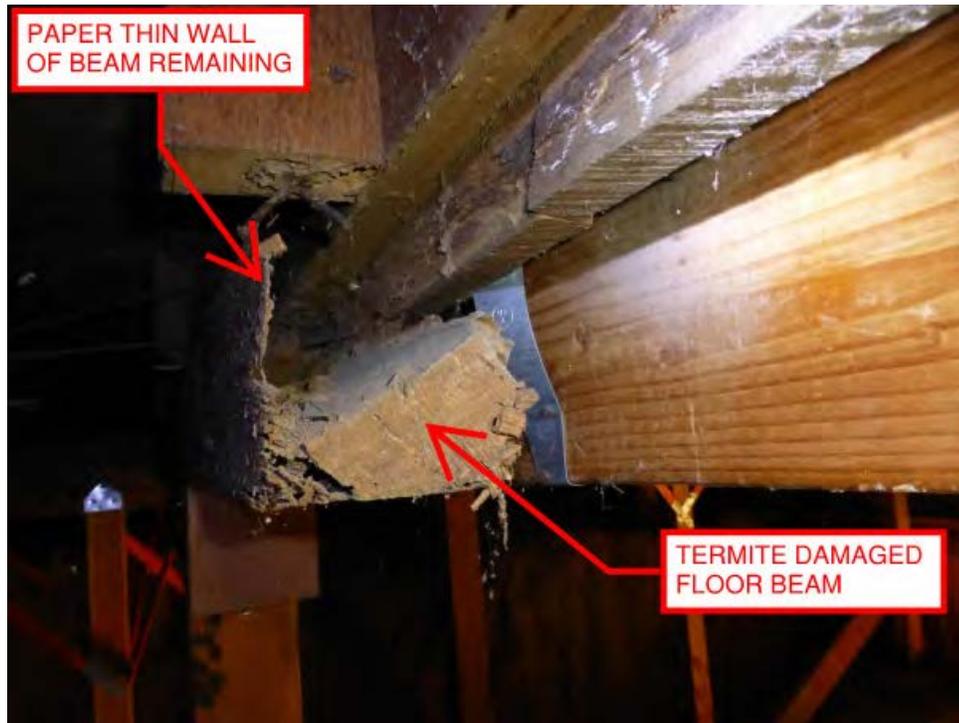
**PHOTO 11: GROUND FLOOR –
TERMITE DAMAGED FLOOR BEAM**

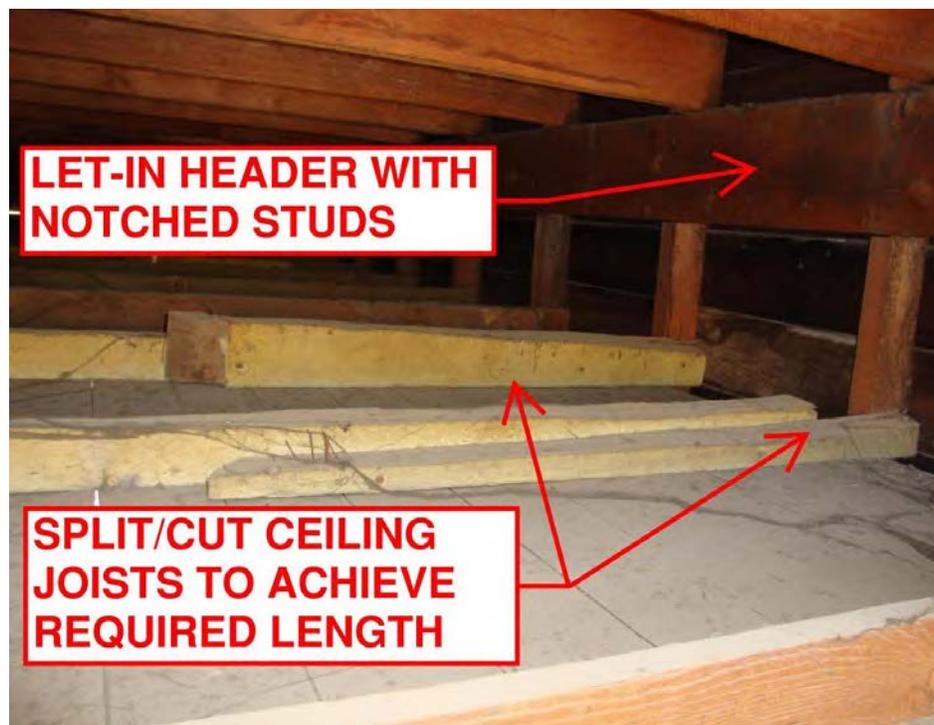
PHOTO 12: INADEQUATE PORCH CEILING FRAMING
