DATE OF INCIDENT/OCCURRENCE 05-13-12		TIME (2400) 0749	NCIC NUMBER 3313	OFFICER I.D. NUMBER 1475	NUMBER P12-067271
"X" ONE <input checked="" type="checkbox"/> Narrative <input type="checkbox"/> Supplemental	"X" ONE <input checked="" type="checkbox"/> Collision report <input type="checkbox"/> Other	TYPE SUPPLEMENTAL ("X" APPLICABLE) <input type="checkbox"/> BA update <input type="checkbox"/> Hazardous materials <input type="checkbox"/> Fatal <input type="checkbox"/> School Bus <input type="checkbox"/> Hit and run update <input type="checkbox"/> Other:			
CITY/COUNTY/JUDICIAL DISTRICT Riverside / Riverside / Riverside			REPORTING DISTRICT/BEAT C/T40	CITATION NUMBER	
LOCATION/SUBJECT Madison St. south of Emerald St.			STATE HIGHWAY RELATED <input type="checkbox"/> Yes <input checked="" type="checkbox"/> No

LOCATION/SUBJECT	
Madison Street at Emerald Street	/ Collision Reconstruction

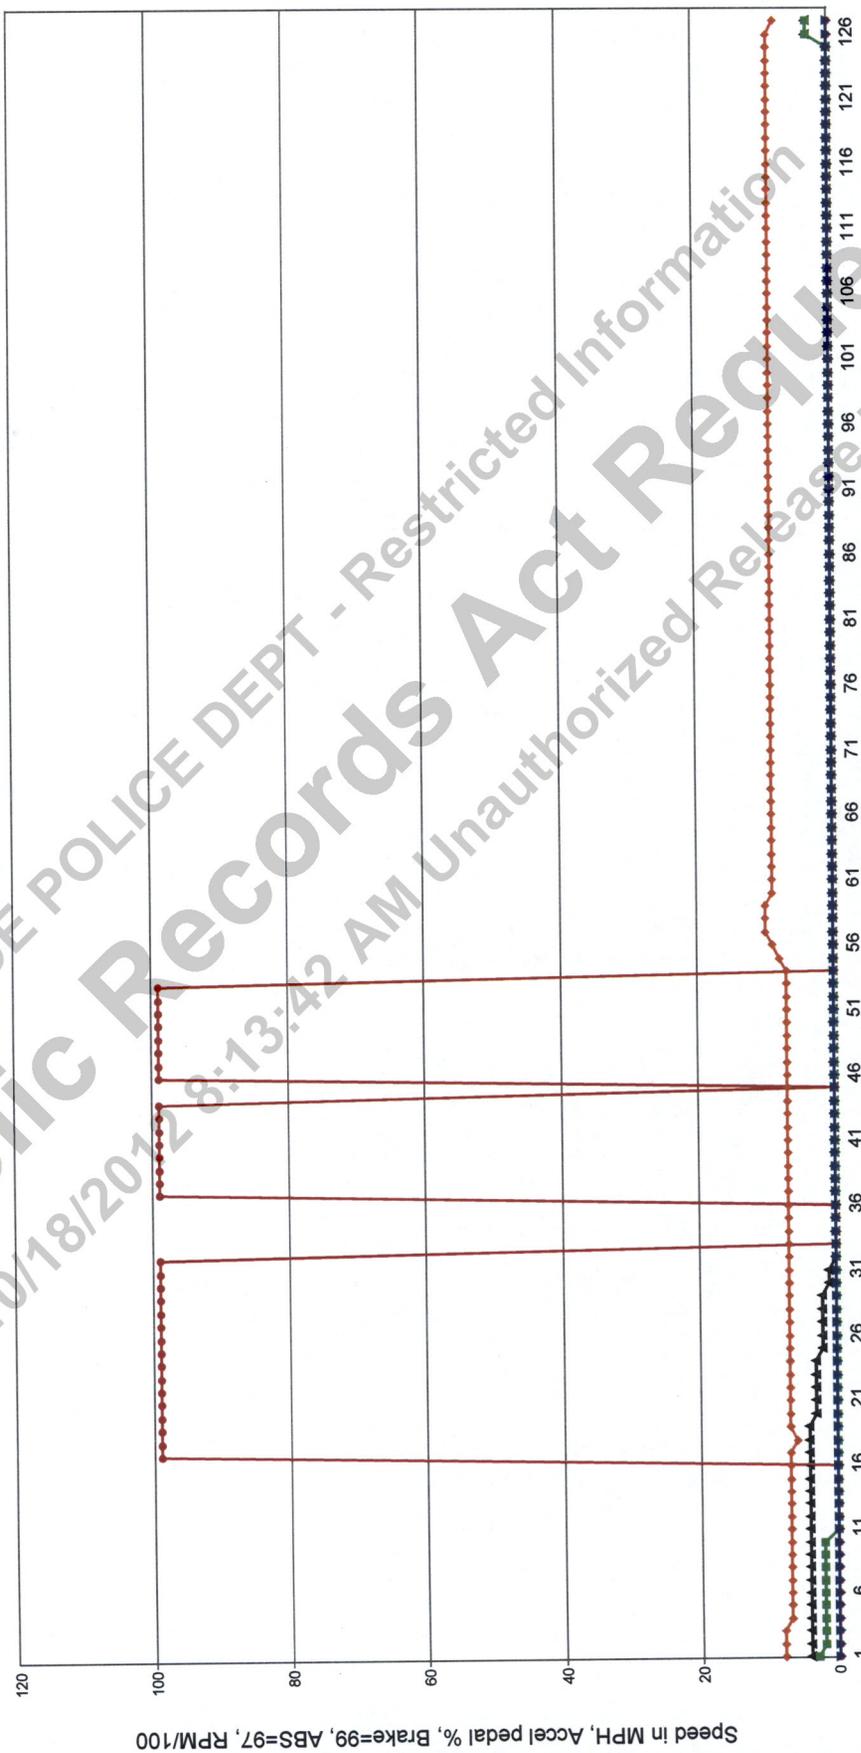
2FAHP71V99X145964 PCM EDR Crash Data - RDS Not Received

PCM EDR samples in order of the buffer address

The Powertrain Control Module (PCM) is designed to store vehicle speed, brake switch status, ABS status, accelerator pedal position, and other parameters for 20 seconds before the crash and 5 seconds after the crash at 0.2 second intervals. The module is designed to trigger a data "locking" signal when the airbags or seatbelt pretensioners deploy. Under some circumstances, such as electrical short circuits caused by crash damage, or complete power loss in the vehicle, the locking signal might not be triggered. In the absence of a locking signal, the recorder within the module is designed to continuously overwrite itself, and after 25 seconds of continuous power without a lock signal, the data relevant to the event is overwritten and lost.¹

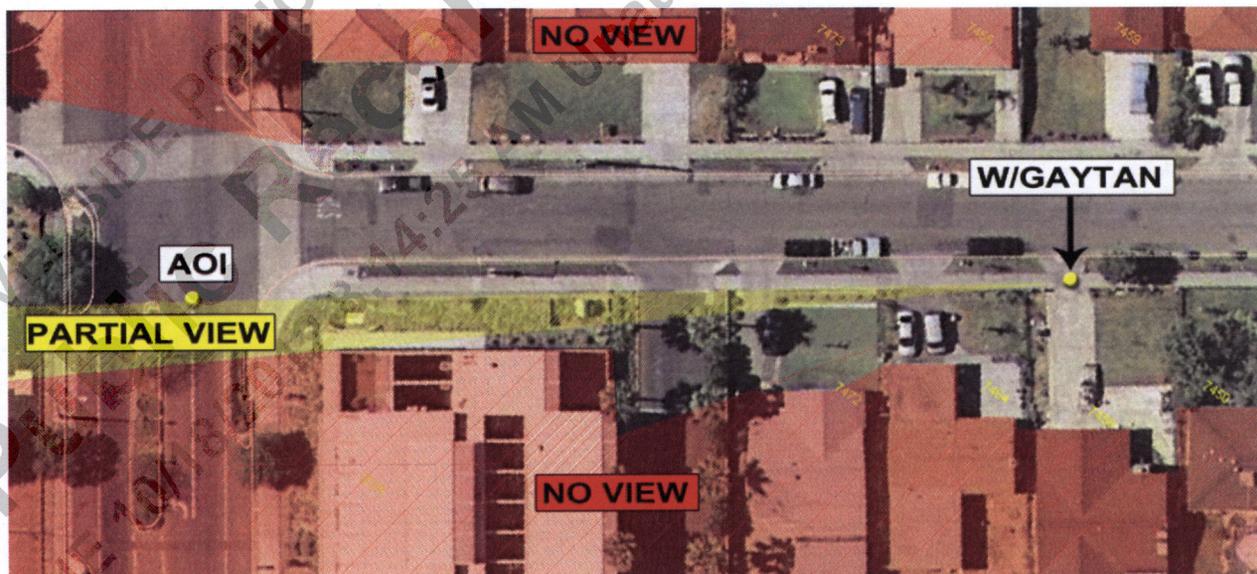
Witness-Gaytan's position in front of his residence would have resulted in a very limited possible view of the collision.

Witness-Gaytan's original statement, recorded by Officer Nakamura's COBAN recording (Video #2), also helps prove he did not actually see the collision; he said Pedestrian-Pablo had crossed in the "crosswalk," when in fact, she had not (COBAN video; point of rest of Vehicle-1). In addition, if one stands on the sidewalk at Witness-Gaytan's driveway, it is only possible to see a few feet south of the area of impact. If he had actually been looking towards the collision at the time of impact, he would have only been able to see the last 35-40 feet of Vehicle-1's travel prior to coming to rest. Please see **Photographic Line of Sight Study** for further.

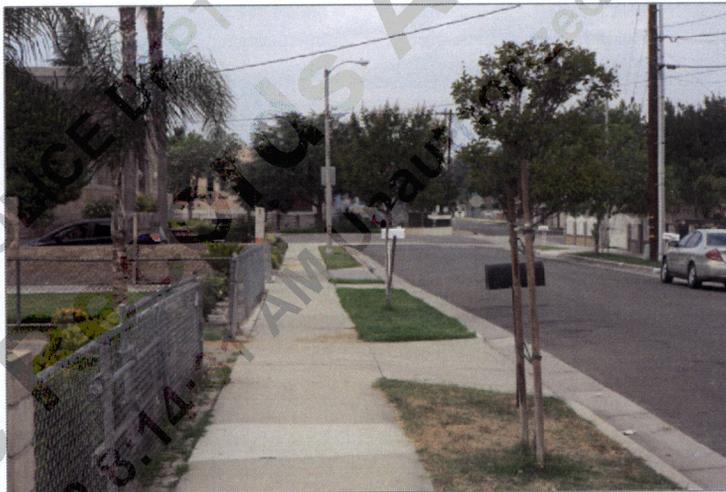
View from center of driveway in front of Witness-Gaytan's house.

The first series of photographs were taken around the driveway to Witness-Gaytan's residence (7458 Emerald Street). I placed a measuring tape in his driveway and extended it approximately 28 feet from the southern roadway curb edge towards his house. I took photographs looking towards the area of the collision in two-foot increments.

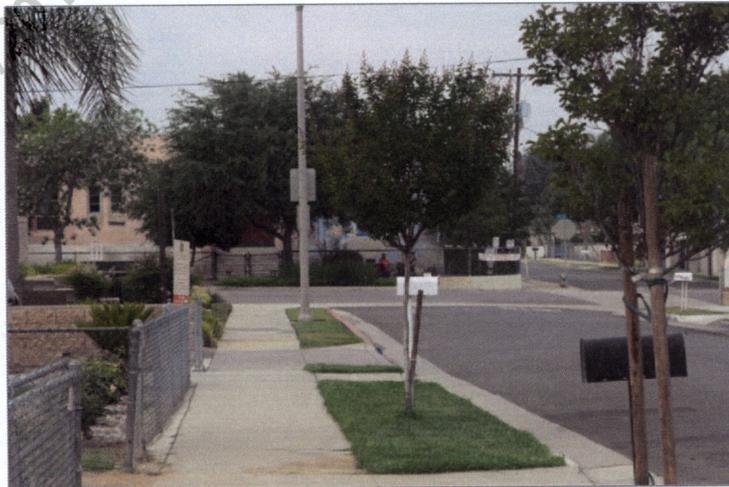
Zoomed image showing extent of Madison Ave visible from Witness-Gaytan's driveway.

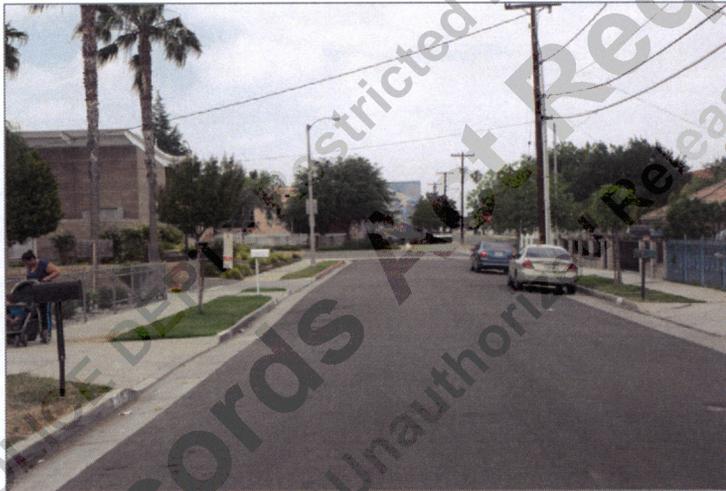
View from center of street in front of Witness-Gaytan's house on Emerald Ave

I next extended the measuring tape from the southern roadway curb edge, north into the street. I took photographs towards the collision scene every two feet, out to 20 feet.

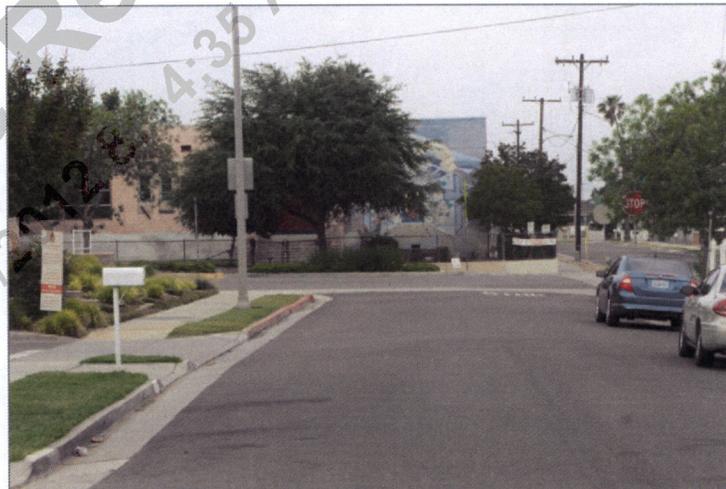
Zoomed image showing extent of roadway view from center of Emerald Ave

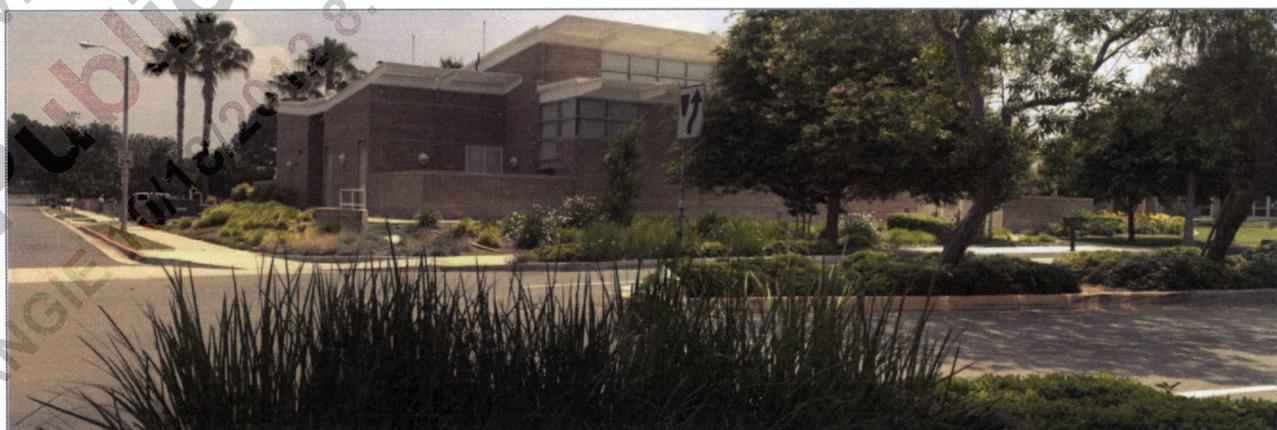
A portion of the available view, looking from the southwest corner of Madison Street and Emerald Street, towards the southeast corner of the intersection and the area of the collision.

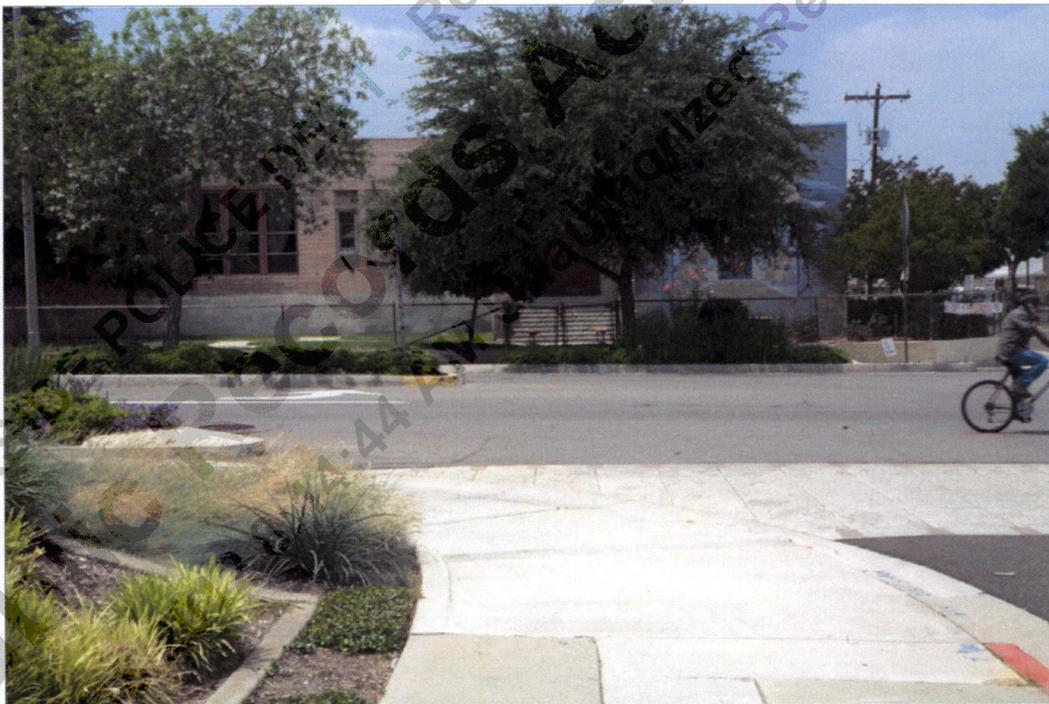
View from the southeast corner sidewalk edge of Emerald Ave and Madison St, showing the landscaped planter/island.

Madison Street at Emerald Street is divided by two concrete islands and a center median. If one extends the south sidewalk across the intersection at 90 degrees to Madison Street as indicated in *California Vehicle Code 275 Sidewalk Definition*, the path is interrupted by a landscaped concrete island on the west side of the street. I took photographs from the east side of the intersection, facing west, showing the interrupted path.

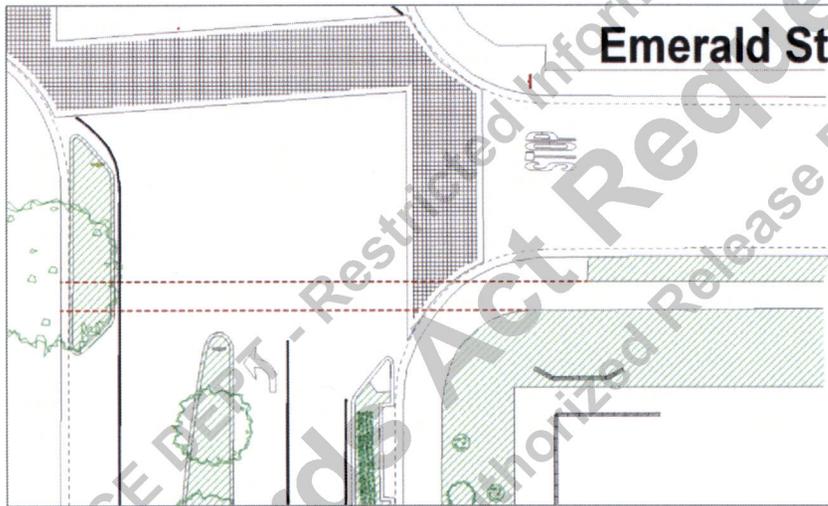
Extension of the south sidewalk across Madison shows that it is interrupted by an island/planter, not allowing direct access to cross the street.

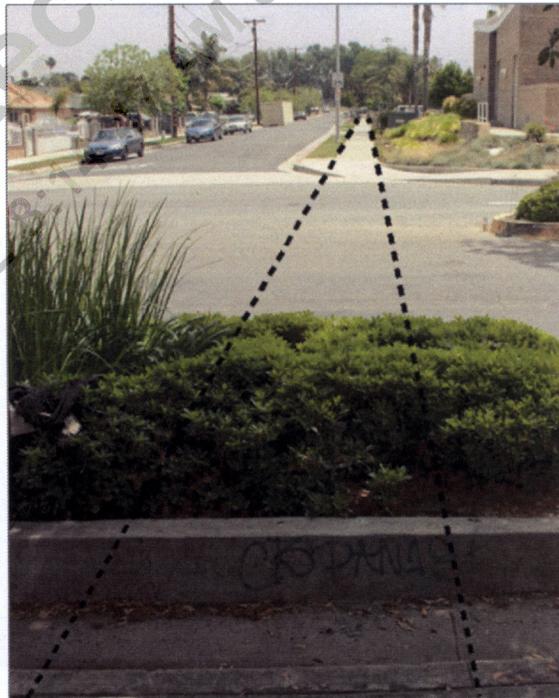
Extension of the sidewalk west from the southeast corner of Madison and Emerald shows that the path is interrupted by a concrete island planter.

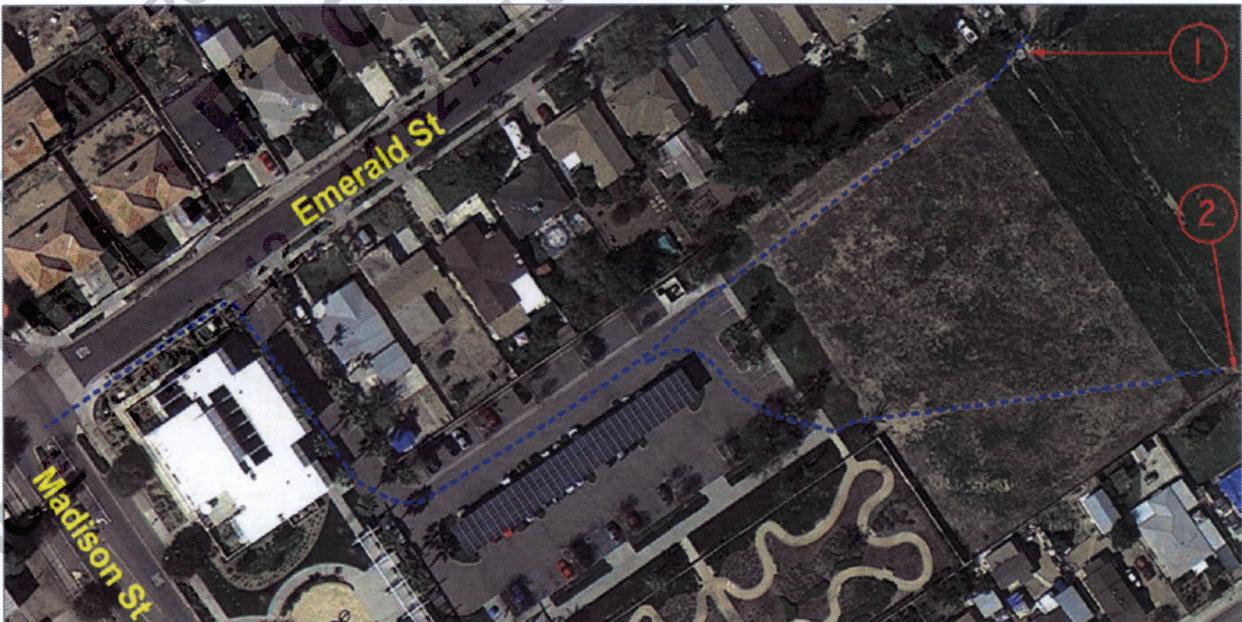
Possible routes of travel taken by Pedestrian-Pablo to the collision scene

Video #3 shows Pedestrian-Pablo walking west through the rear parking lot of the RPU Customer Service Building. The eastern end of the parking lot is bordered by a large dirt field. The field has two well-worn paths leading to the only entry/exit points and is bordered on three sides by chain link fences. The first entry point is at the northeast corner where the fence has been cut to allow travel to/from Ysmael Villegas Park. The second entry point is at the southeast corner of the field where the fence has been broken away, providing access to Bunker Street, which leads south to Lincoln Avenue. I took photographs along both paths back to the collision scene, depicting both of Pedestrian-Pablo's possible paths of travel. As I approached the collision scene on Emerald Street, I took photographs at various points depicting the available view of Madison Street to the south.

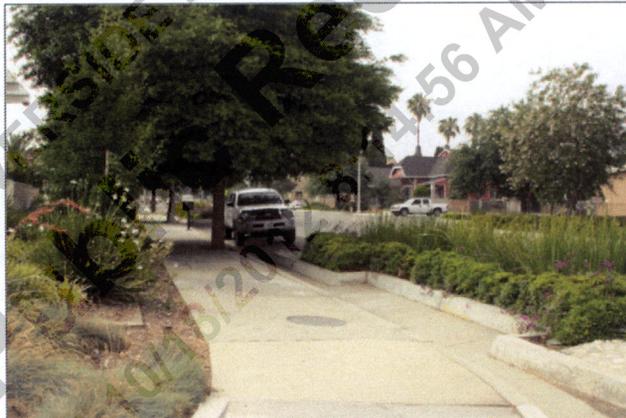
Standing at the sidewalk's end, at the edge of the pavement, Pedestrian-Pablo would not have had a clear view of Vehicle-1 as it approached (19 feet east of east fog line).

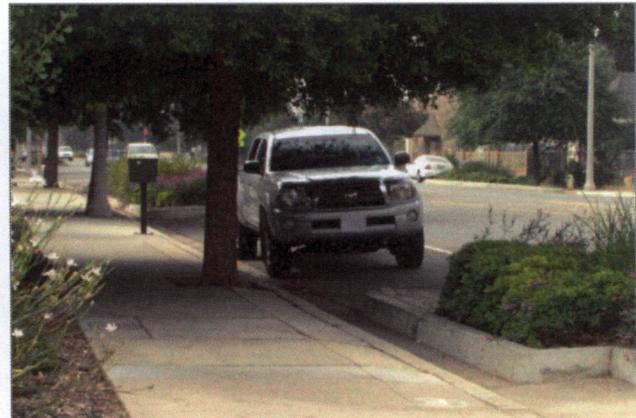
A zoomed view of the image to the left shows the landscaping, trees, and the parked vehicle serve to greatly reduce the available view of northbound traffic to a pedestrian at the end of the sidewalk.

As I approached the street, I saw that the Toyota truck, shrubbery and trees served to greatly reduce my view of approaching northbound traffic on Madison Street from the south. From my position at the southeast corner of the intersection, I was only able to see approximately 85 feet to the south.

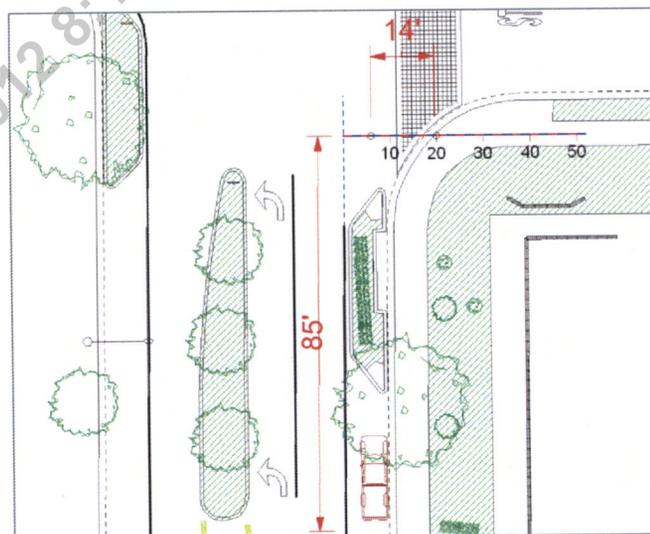
Detailed view of line of sight locations – 20 ft back from the fog line at the end of the sidewalk, and 14 feet into the street from the sidewalk's end

The view looking south on Madison Street, 14 feet west of the end of the south sidewalk, approximately 6 feet east of the western fog line.

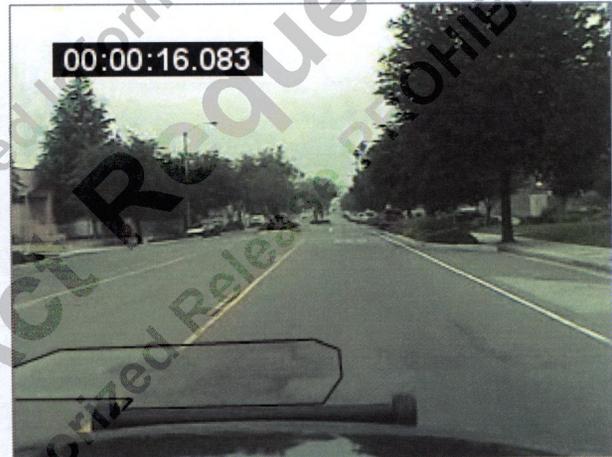
Video frame capture: Reference area enhanced

Further examining the video I located a frame where the front push bar aligned with the bottom of the painted "PED" warning on the roadway surface, at approximately 18 seconds (18.218).

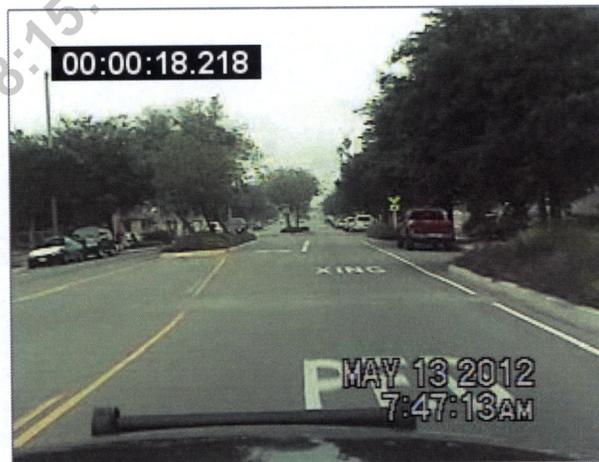
Location 2: Video frame capture with "PED" warning

On 8 June 2012, Detective Madsen and I returned to the area of Madison Street and Emerald Street. I used a fiberglass measuring tape to measure the distance separating the two identified reference locations. The distance is 125.3 feet.

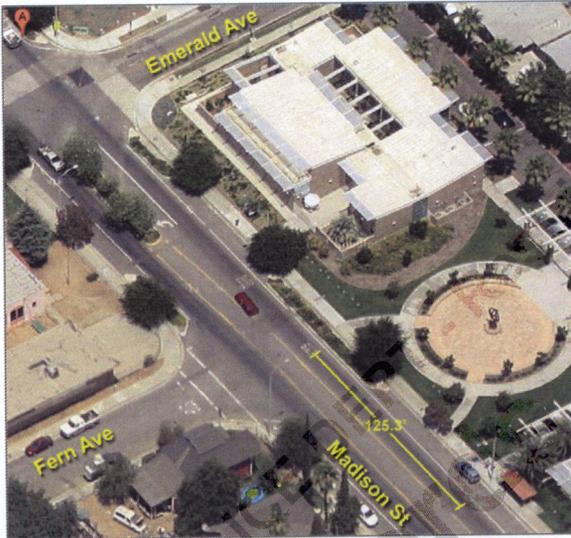
Location of area identified for speed analysis measurement

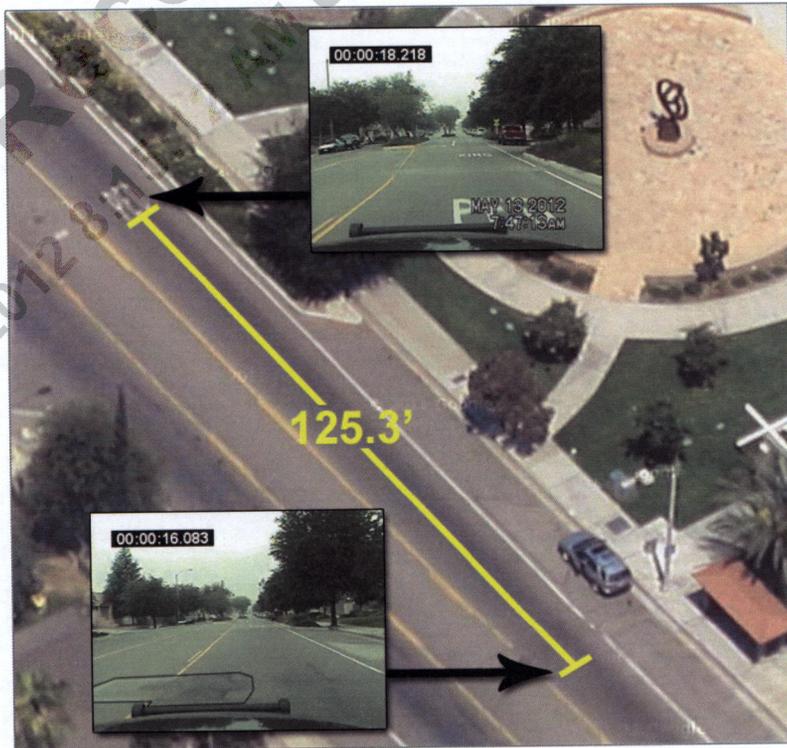
Overview of area identified for speed analysis measurement

Detail of speed analysis measurement area

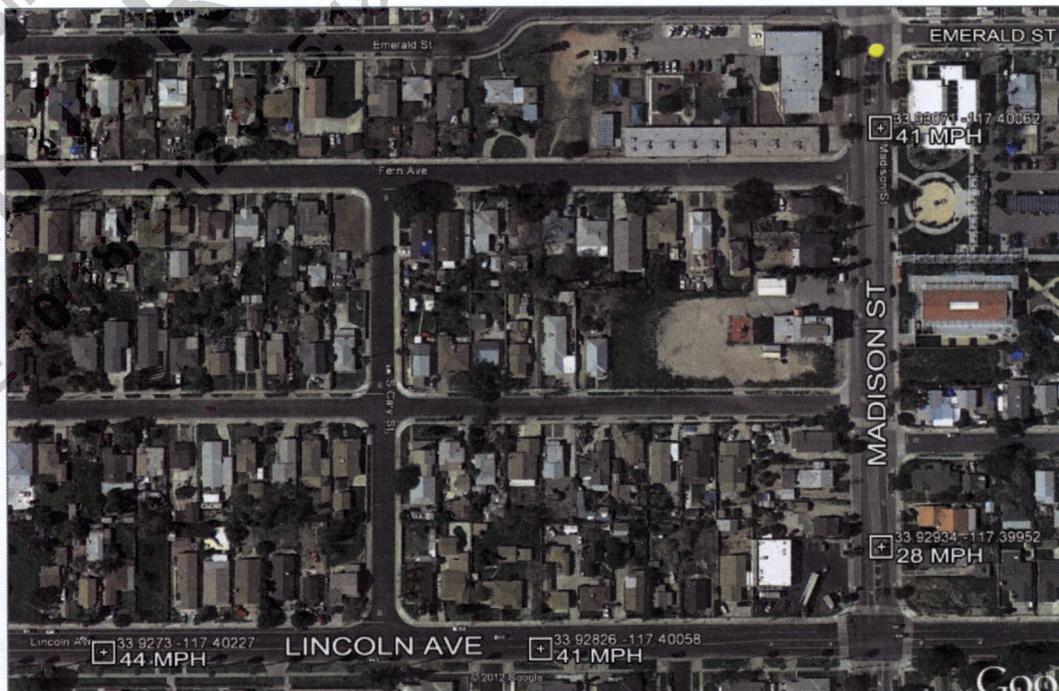
According to the data recorded, Vehicle-1 recorded two location data points on Madison Street prior to the collision (there were numerous data points recorded after, but they all have indicated a speed of 0 miles per hour until the car was turned off).

The first data point was approximately 100 feet north of Lincoln Avenue. It recorded a speed of 27 miles per hour. The second data point was approximately 1/10th of a mile later, or approximately 108 feet south of the area of impact, and recorded a speed of 41 miles per hour.

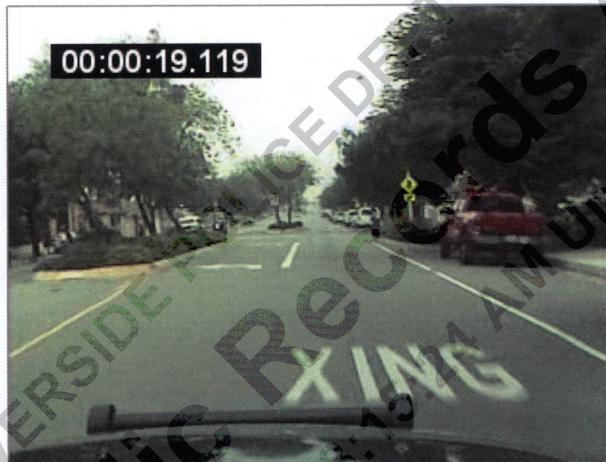
Pedestrian walking reference point #1

In order to determine the walking speed of Pedestrian-Pablo, I analyzed the COBAN video modified with the time stamp from the District Attorney's office. I identified two key frames within the video. The first frame shows Pedestrian-Pablo as she appears to walk even with the western concrete edge of the island planter on Madison Street, along the east side of the roadway. This frame is time stamped 00:00:19.119 seconds. The second frame shows Pedestrian-Pablo as she reaches the center of the northbound traffic lane. This frame is time stamped 00:00:20.754 seconds.

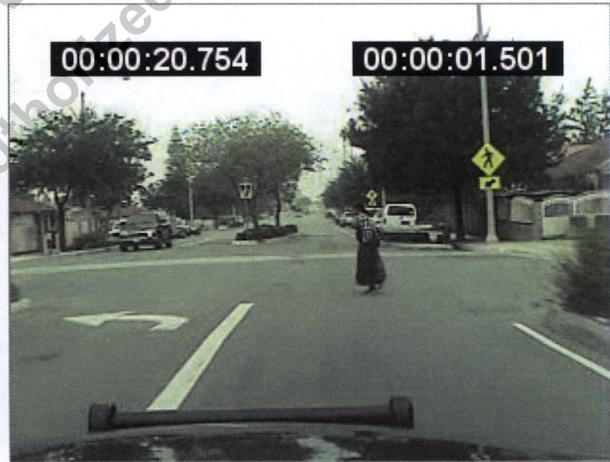
Pedestrian walking reference point #2

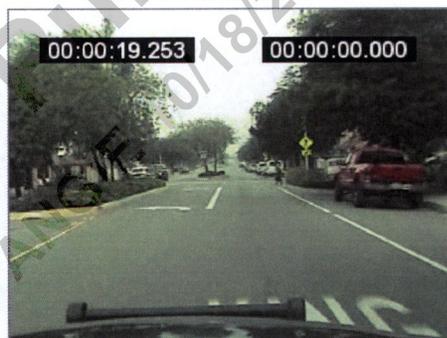
Pedestrian-Pablo first becomes visible to Driver-Boulerice.

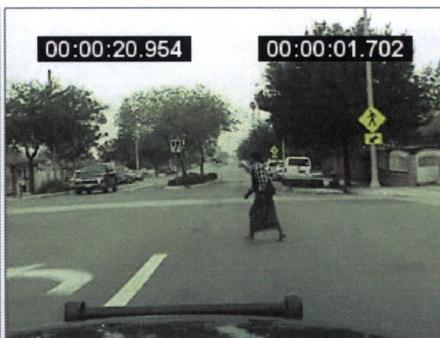
Driver-Boulerice applies the brakes in an attempt to stop his vehicle.

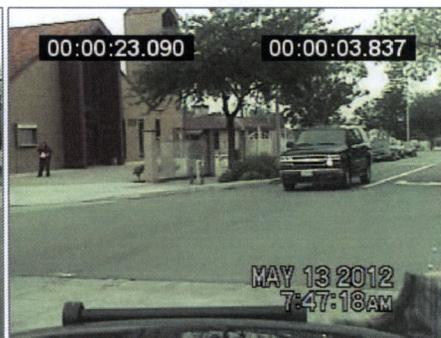
Vehicle-1 comes to a complete stop.

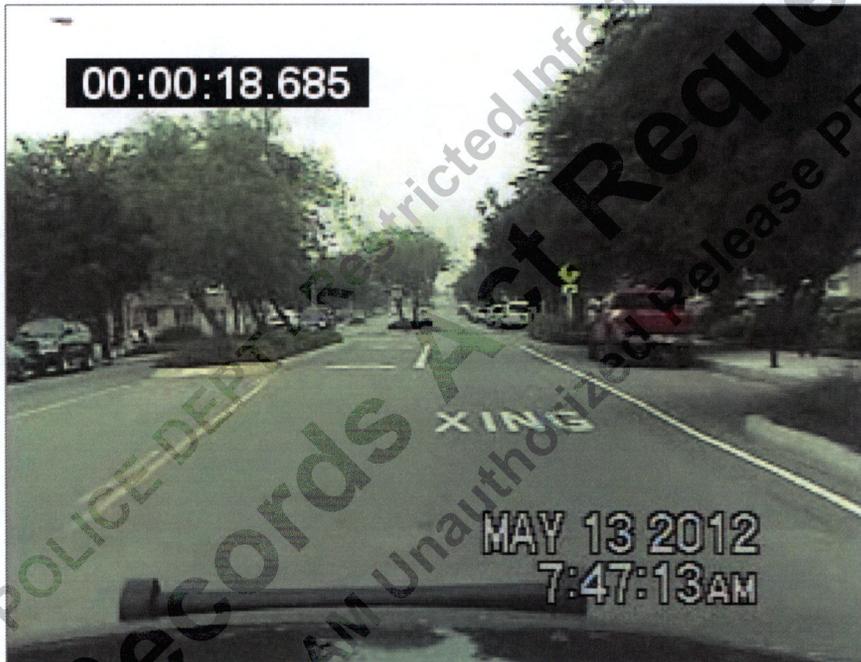
Prior to stepping into the street, Pedestrian-Pablo cannot be seen. The red pickup truck, parked along the east shoulder, the plants in the planter/islands, and the trees planted along the east shoulder all serve to block the view of an approaching motorist.

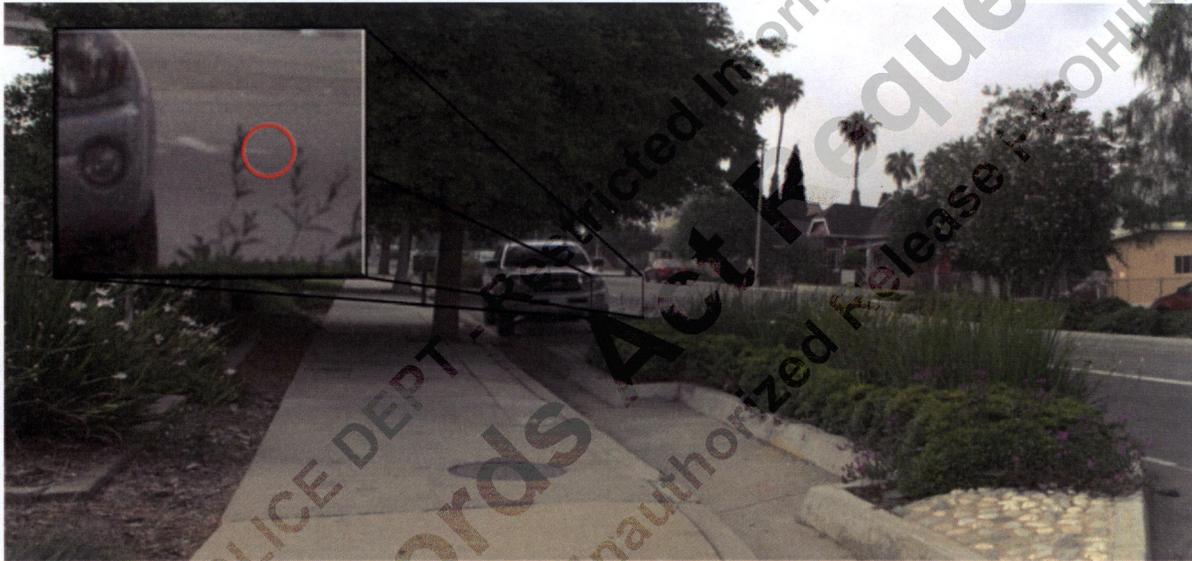
16 Feet East of the Fog Line (23.4' East of AOI, 5.89 seconds prior to impact)

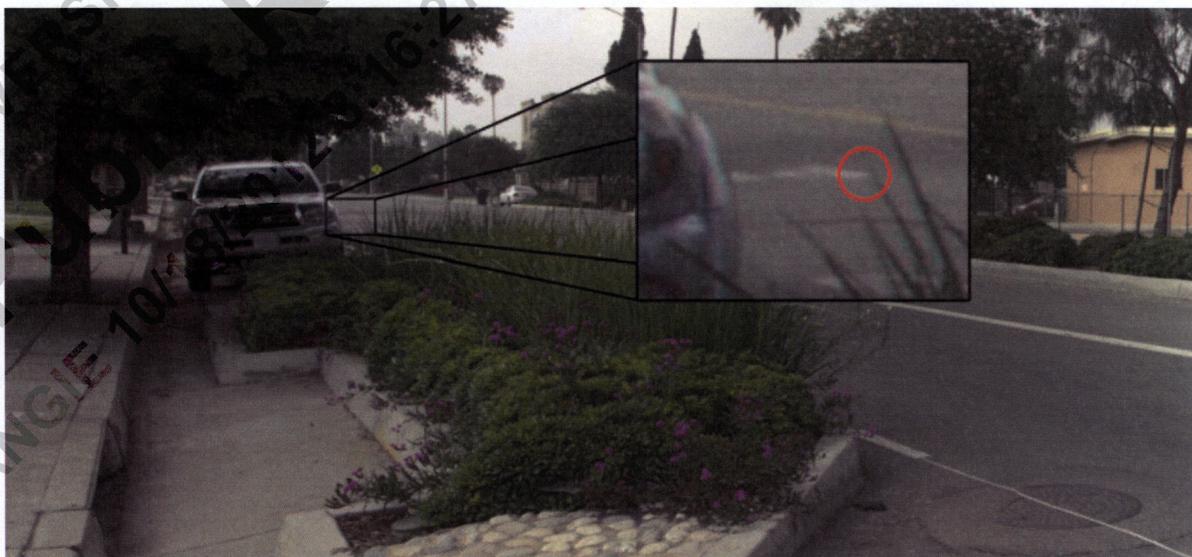
10 Feet East of the Fog Line (17.4' East of AOI, 4.38 seconds prior to impact)

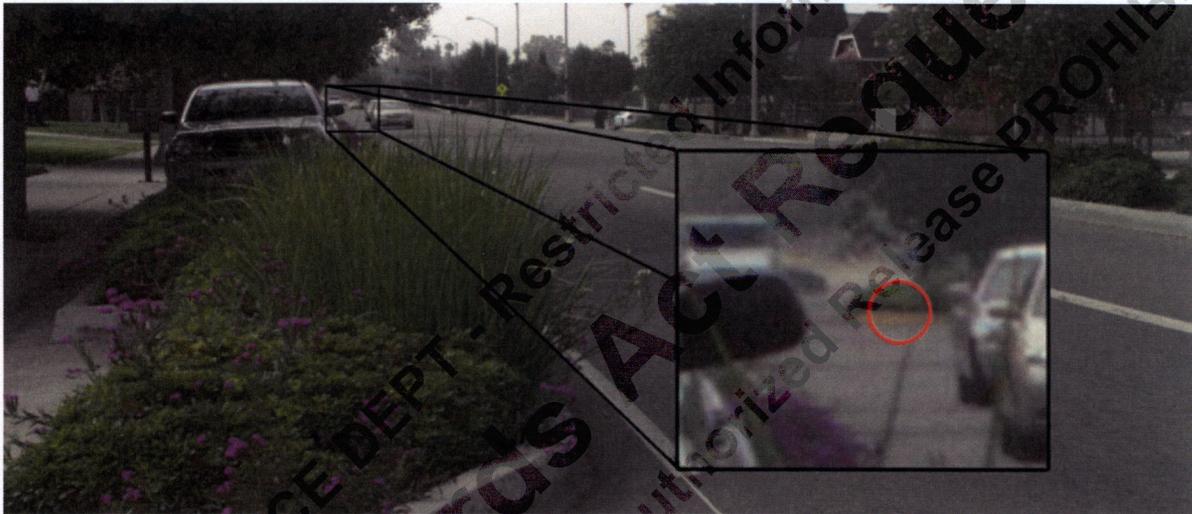
4 Feet East of the Fog Line (11.4' East of AOI, 2.87 seconds to impact)

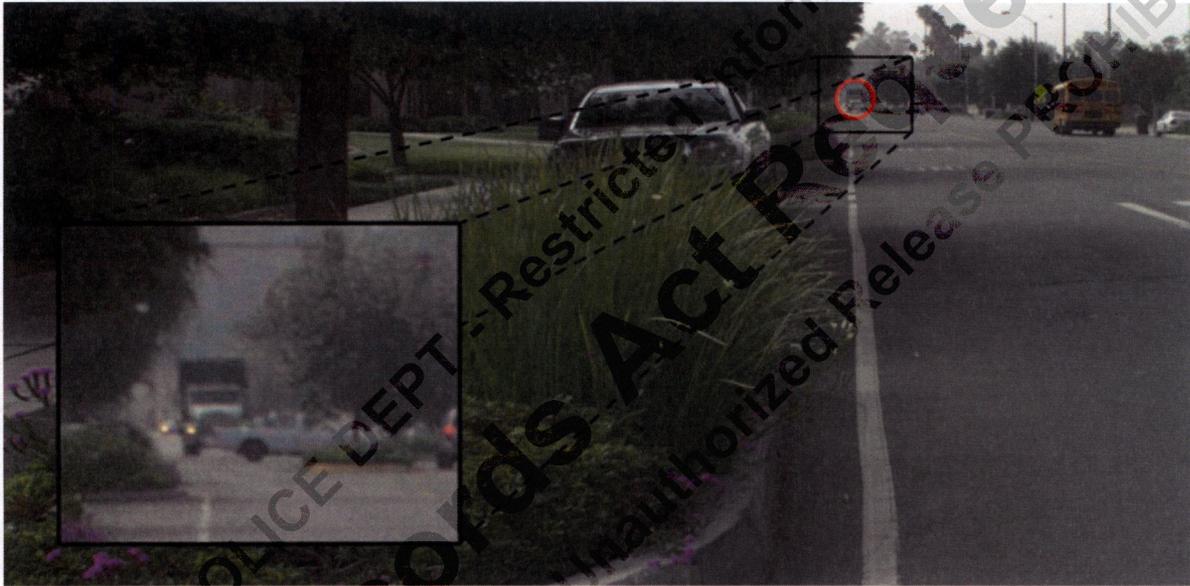
0 Feet – At the Fog Line (7.4' East of AOI, 1.86 seconds to impact)

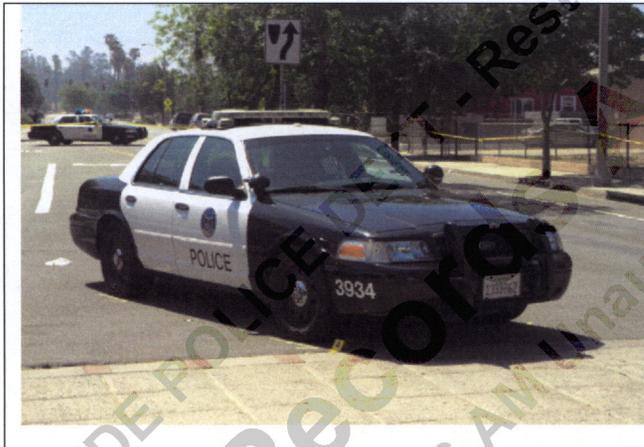
V1 is identified as a 2009 Ford Crown Victoria CA 1333762. It is a marked black and white City of Riverside Police car. It is further identified as Unit #3934. It is equipped with anti-lock brakes.

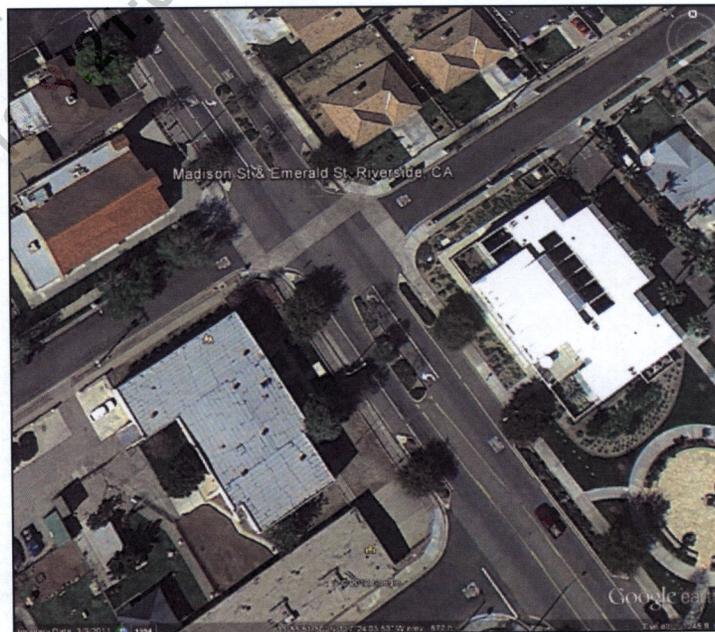
Aerial Photograph of Madison St. & Emerald St.

Emerald intersects Madison at an off set. On the west side of Madison, Emerald is more north than the east side of Madison.

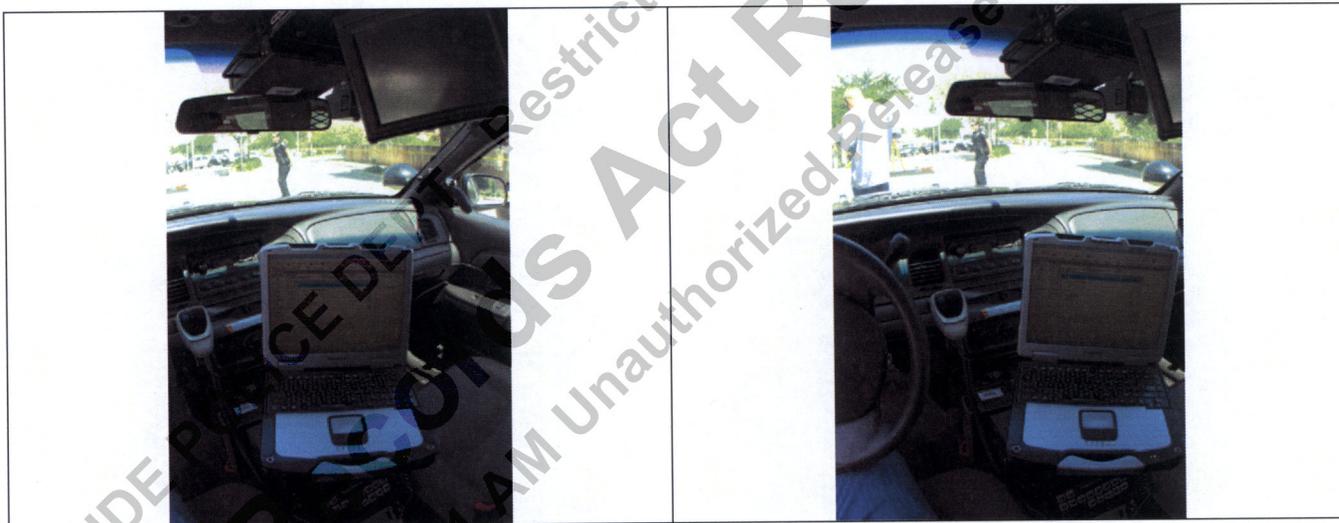
These photographs of the interior of Unit #3934 show the COBAN camera immediately to the right of the rear view mirror at the roofline. The COBAN display screen is located on the headliner and is tilted down and turned toward the driver. The hard drive is situated between the display screen and the rear view mirror. It also shows the MDC.

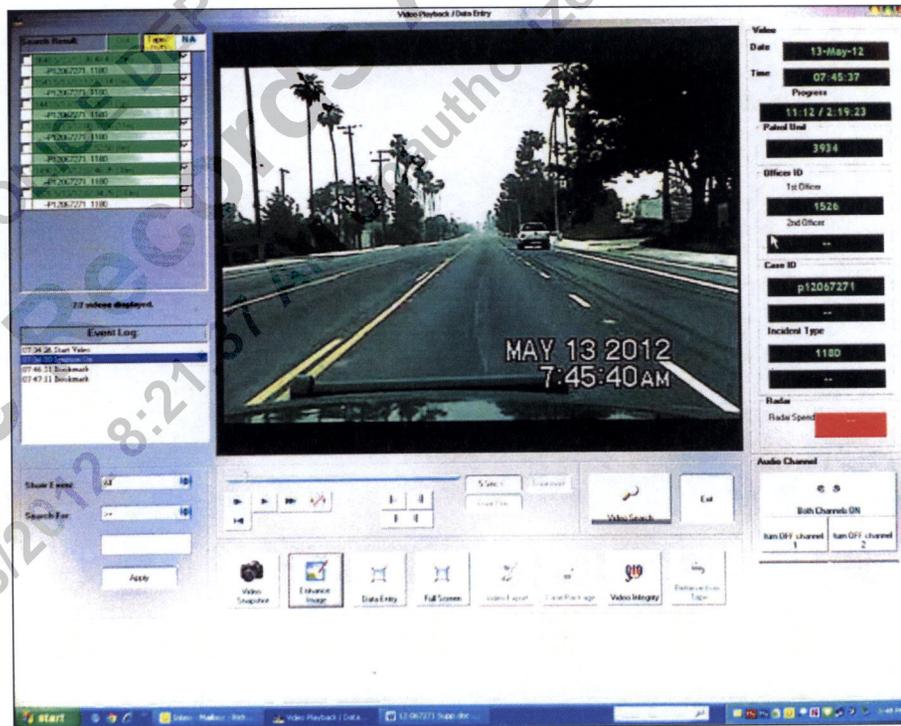
This is a sample screen capture of the COBAN viewing software. The "Video Screen Time" shows 7:45:40 am. The "Video Playback Time" shows 07:45:37.

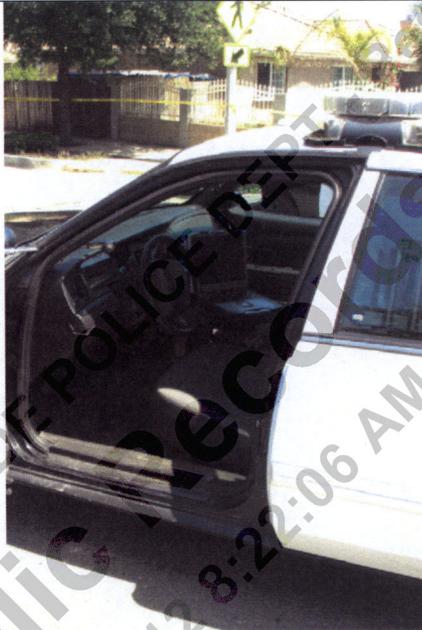
This photograph of the interior of Unit #3934 shows the MDC being swiveled toward the driver. The screen is in the upright and open position.

Note: This photograph was taken several hours after the collision. This photograph does not necessarily depict the position of the MDC at the time of the collision. It is only used to show the location of the MDC.

Unit #3934 is equipped with a Mobile Data Computer (MDC). It is a laptop computer and it is located near the center of the front dash of the police car. It can be swiveled to the left or right for use by the driver or right front passenger. During the boot up process, the MDC computer obtains "time" from the Riverside Police Department Orange Station server.

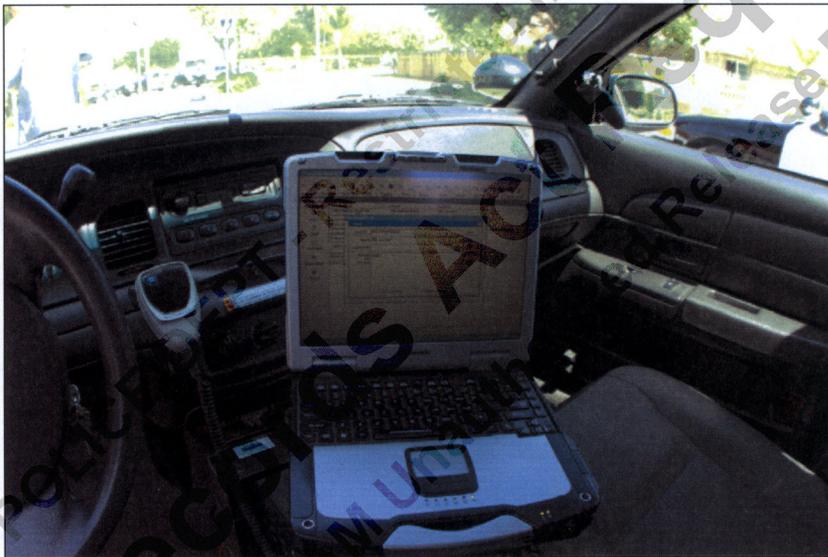
There was a partially typed message on the MDC screen.

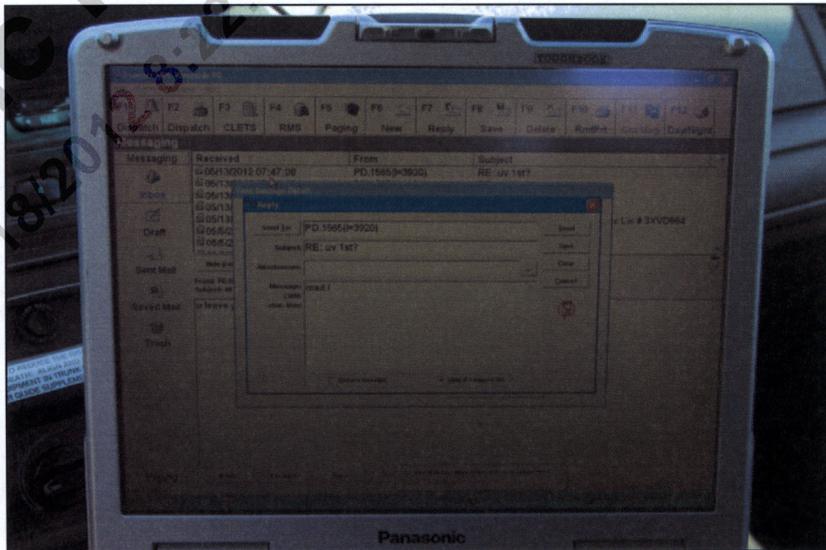
Closer inspection of the screen revealed a second message layered behind the visible message.

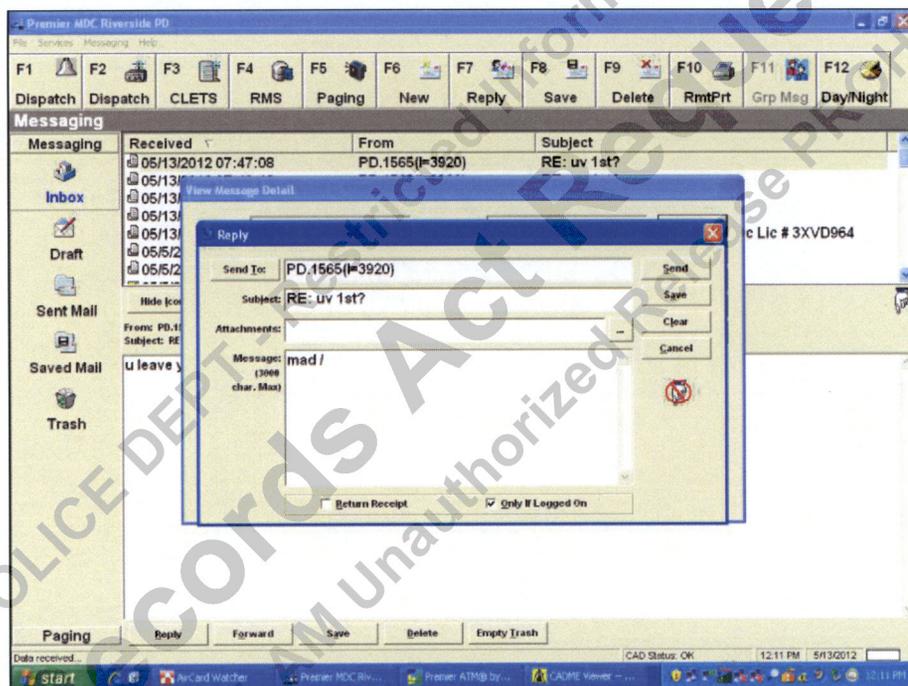
This image is a "screen capture" of the MDC screen. The top message is marked "Reply." This is a response to the message received from Officer J. Miller #1565. There is no time stamp to indicate when Officer Boulерice typed this message. The message appears to be incomplete and it had not been sent to Officer Miller.

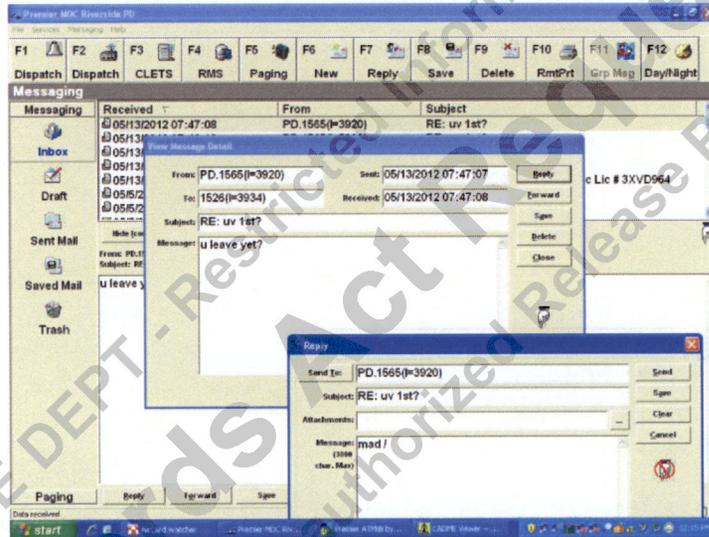
Officer Matthews moved the "Reply" message to the side to reveal the message behind it. Again, this image is a "screen capture" of the MDC screen. The message is marked "View Message Detail." This is the message Officer Boulerville received from Officer Miller. The message indicates Officer Miller sent this message on 05/13/2012 at 07:47:07 hours. It also indicates Officer Boulerville's MDC received the message on 05/13/2012 at 07:47:08 hours.
