CALIFORNIA TRAFFIC SPECIALISTS

Re: Fatal Traffic Collision Investigation

Report No.: P12067271
Date of Loss: 5/13/2012
CTS Number: 4582

Traffic Collision Reconstruction Review Report

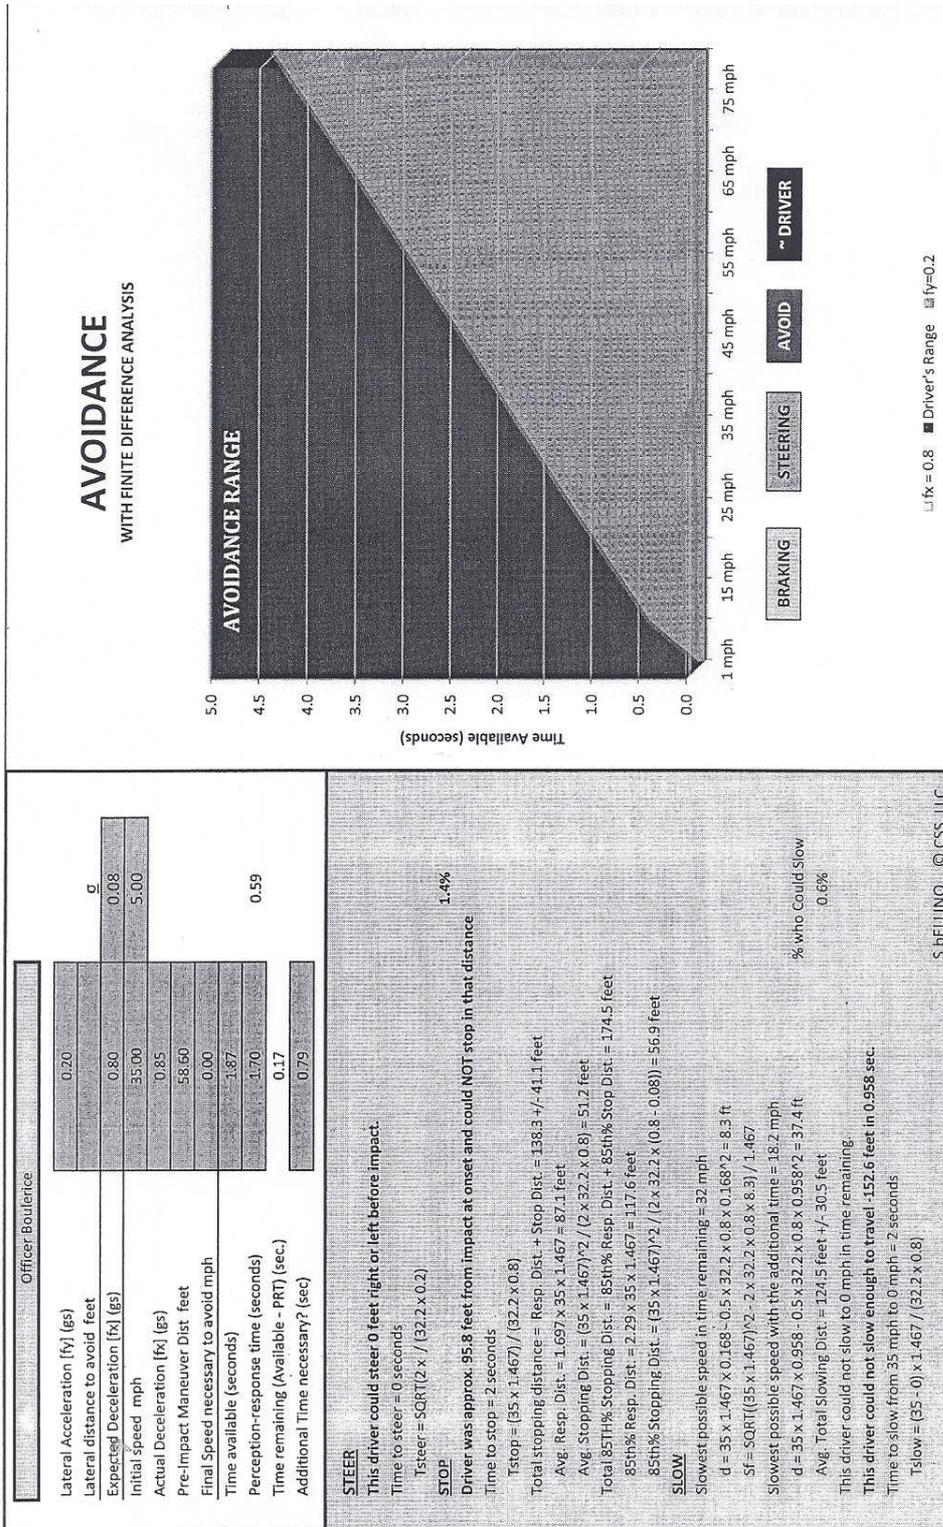
PATH INTRUSION		RESPONSE TO PATH INTRUSION	
S BELLINO © CSS, LLC 5. Hazard & Appro Response Unknown ***DEFAULT*** 4. Road/Hi Fidelity Sim ***DEFAULT*** 1. Response to one object *CALCULATE ECCENTRICITY* 1. Straight Road 3. Full Response (250 ms veh delay) <input type="checkbox"/> Check if hovering brake		Officer Boulterice Primary Driver Initial Speed 35.0 mph Braking Response 3.0 Avg. Deceleration factor 0.8 gs S BELLINO © CSS, LLC	
Pedestrian Isabel Pablo <input type="checkbox"/> Check if using Mobile Phone 1. Driving 7.4 0. SV Not Turning 127.8 1. Day 3.3 1. Subj did not discern other unit stop		Response Distance = $1.7 \times 35 \times 1.467$ eq.3 Distance to Stop = $(35 \times 1.467)^2 / (2 \times 32.2 \times 0.8)$ eq.4 Total Stopping Distance = 88 feet + 51 feet eq.5 Time to Brake = $\text{SQRT}(2d / g \times f) = 2 \text{ sec}$ eq.6 TOT - STOPPING DIST. 139 feet eq.5 AVG. Response Dist. 88 feet eq.3 85th percentile response Dist. 119 feet Stopping Dist. 51 feet eq.4 85th percentile respon 170 feet

Braking Adj + $(413 \times Tr) + 30E + 224Lt + 716O - 496Tp - 164M + 261Tn + 350(D - 1) + 7$ eq.1 $0 + (413 \times 3) + 30 \times 3.3 + 224 \times 1 + 716 \times 1 - 496 \times 1 - 164 \times 1 + 261 \times 0 + 350 \times (1 - 1) + 7$ eq.2 85th percentile response 2.3 sec Individuals		AVERAGE PRI 1.7 sec Equation 1.6 sec A2B studies 1.8 Sec Resp to Vehicle 1.8 Sec Resp to Ped. 1.8 Sec Resp to Object 1.8 Sec	
Min Avg 1.4 Sec 1.5 Sec 1.5 Sec 1.4 Sec		Max Avg 2.1 Sec 2.0 Sec 2.1 Sec 2.0 Sec	
Scenarios		85th %ile STOPPING DIST. 170 feet

This expert conducted an independent evaluation and analysis of Officer Boulерice's response to the path intrusion by pedestrian Isabel Pablo based upon the information reconstructed by the Riverside Police Department in order to determine if the collision could have been avoided. A human factors computer program titled Integrated Driver Response Research by Crash Safety Research Program from the University of Connecticut was used to evaluate if Officer Boulерice could have avoided the collision. It was concluded that Officer Boulерice could not have avoided the collision. The results of the analysis and evaluation are attached.

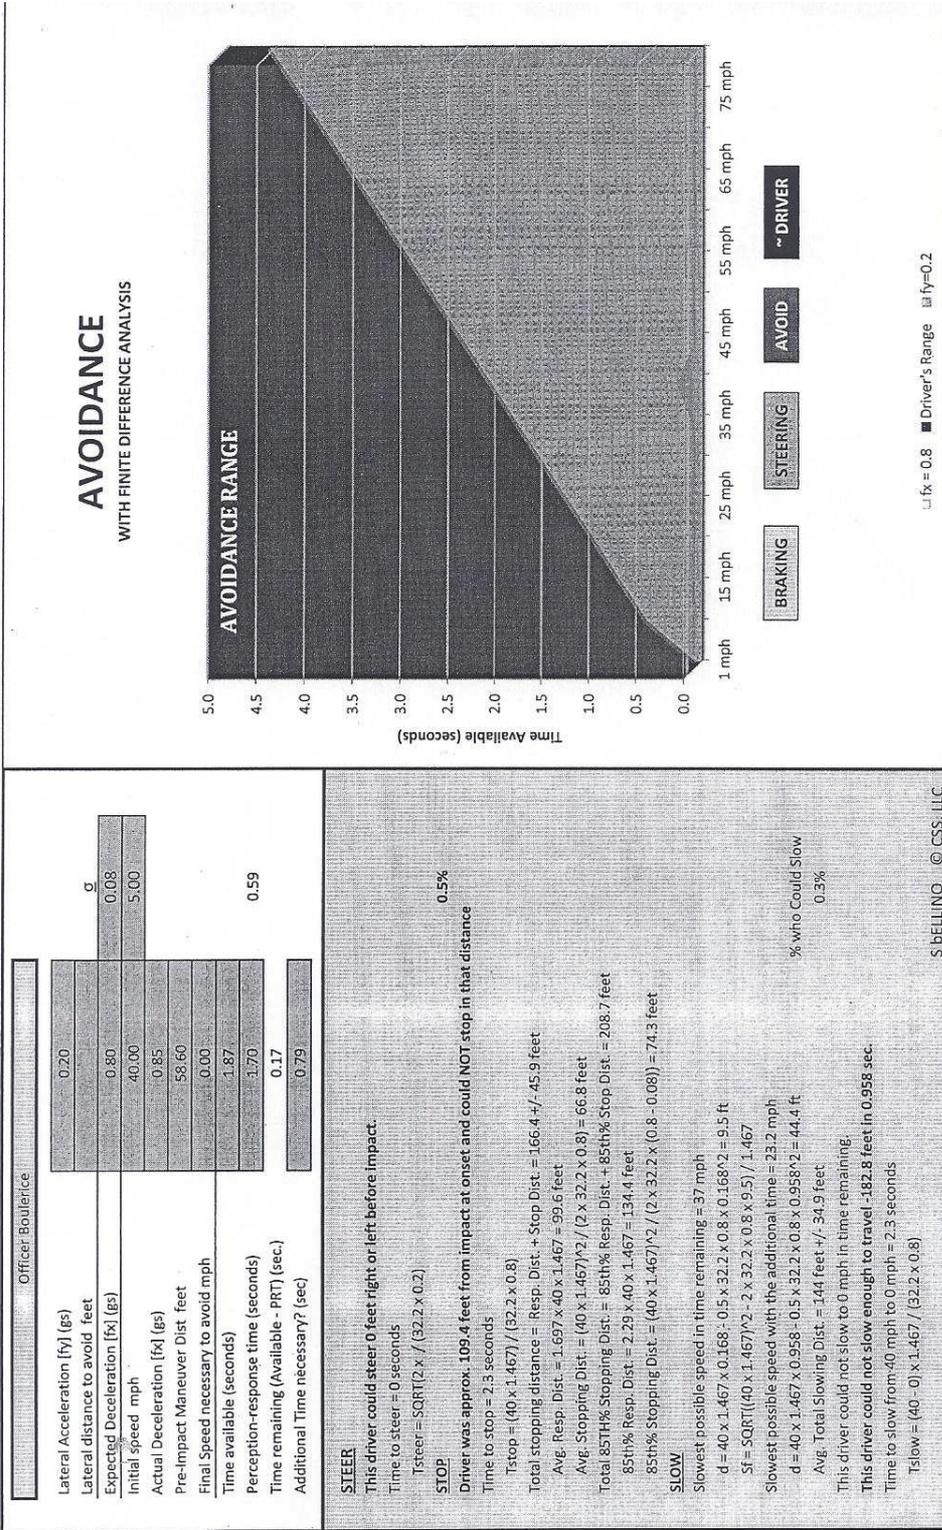
PATH INTRUSION		RESPONSE TO PATH INTRUSION	
S BELLINO © CSS, LLC 5. Hazard & Appro Response Unknown ***DEFAULT*** 4. Road/Hi Fidelity Sim ***DEFAULT*** 1. Response to one object *CALCULATE ECCENTRICITY* 1. Straight Road 3. Full Response (250 ms veh delay) <input type="checkbox"/> Check if hovering brake		S BELLINO © CSS, LLC Pedestrian/Isabel Pablo <input type="checkbox"/> Check if using Mobile Phone 1. Driving 0. SV Not Turning 1. Day 1. Subj did not discern other unit stop	
Braking Adj + (413 x Tr) + 30E + 224Lt + 716O - 496Tp - 164M + 261Tn + 350(D - 1) + 7 0 + (413 x 3) + 30x3.3 + 224x1 + 716x1 - 496x1 - 164x1 + 261x0 + 350 x (1 - 1) + 7		eq.3 eq.4 eq.5 eq.6 eq.5 eq.3 eq.4	
AVERAGE PRI Equation 1.7 sec 1.6 sec 1.8 Sec 1.8 Sec 1.8 Sec 1.8 Sec		Response Distance = $\sqrt{1.7 \times 40 \times 1.467}$ Distance to Stop = $(40 \times 1.467)^2 / (2 \times 32.2 \times 0.8)$ Total Stopping Distance = 100 feet + 67 feet Time to Brake = $\text{SQRT}(2d / g \times 1) = 2.3 \text{ sec}$ TOT. STOPPING DIST: 167 feet AVG. Response Dist. 100 feet 85th percentile response Dist. 136 feet Stopping Dist. 67 feet

85th percentile response 2.3 sec Individuals Max Avg 2.1 Sec 2.0 Sec 2.1 Sec 2.0 Sec Min Avg 1.4 Sec 1.5 Sec 1.5 Sec 1.4 Sec Scenarios		85th %ile STOPPING DIST. 203 feet
