HARADA HOUSE

**3356 Lemon Street
Riverside, CA 92501**

April 30, 2018

STRUCTURAL ENGINEERING ASSESSMENT REPORT

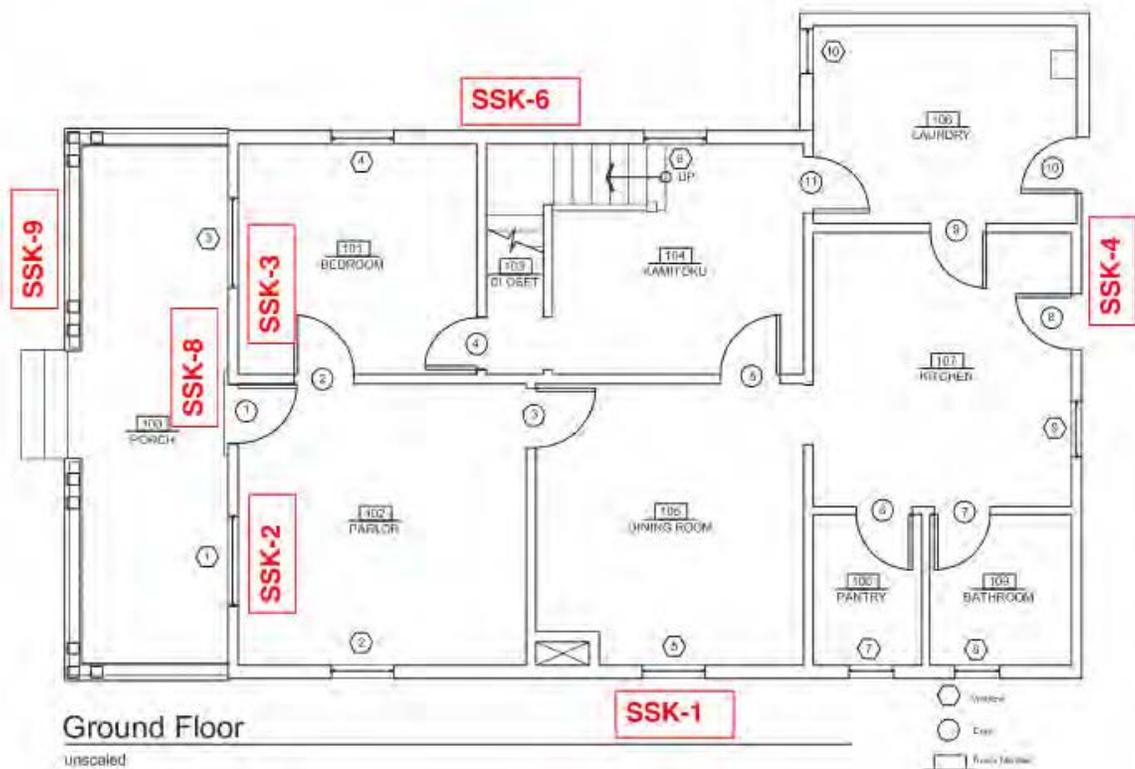
Figure 8 - Ground Floor Temporary Immediate Repair Sketch Locations

2. Temporary Immediate Repairs - During the assessment discovery process, several conditions were found that required immediate measures to stabilize the Harada House. These items fall under the **Immediate Future category**, and the stabilization details provided to the contractor are documented in sketches at the end of this report. Figures 8 and 9 below illustrate where each of the repair sketches were implemented.

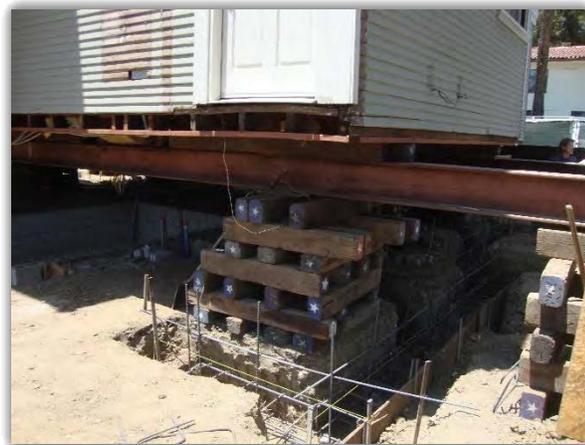
Figure 18 - Lifting of an Existing House for Construction of a new Foundation under the House (July 2017)

The Foundation System is the base of the structure and is the critical component for supporting all levels of a building. New code compliant foundations are needed to properly support the Harada House and anchor the wood framed building to the foundation. Structural Focus previously completed construction documents for new foundations to support the house, but the documents will need to be updated to include leveling the house. Replacing the foundation system will require a specialty contractor that can provide temporary support for the house and lift it to allow for construction of the new foundation system. The process will be a complex and risky undertaking that will likely involve major excavation work under the house. Figure 18 shows an example of a different historic house in Claremont, CA that was lifted and relocated on a new foundation. The photo is taken during construction when the holes for the new foundation were dug and steel reinforcing bars have been placed in the excavation in preparation for placement of new concrete foundations.

- Our recommendation for the Harada House is to construct the new foundation level and set the house on the foundation to restore the house back to a level condition. This will require removal of some of the temporary immediate repair work that was done in order to allow the house to properly sit on the new foundation. While time is of the essence when it comes to stabilizing the house on a proper foundation, this recommendation falls under the **Permanent Solution category**.

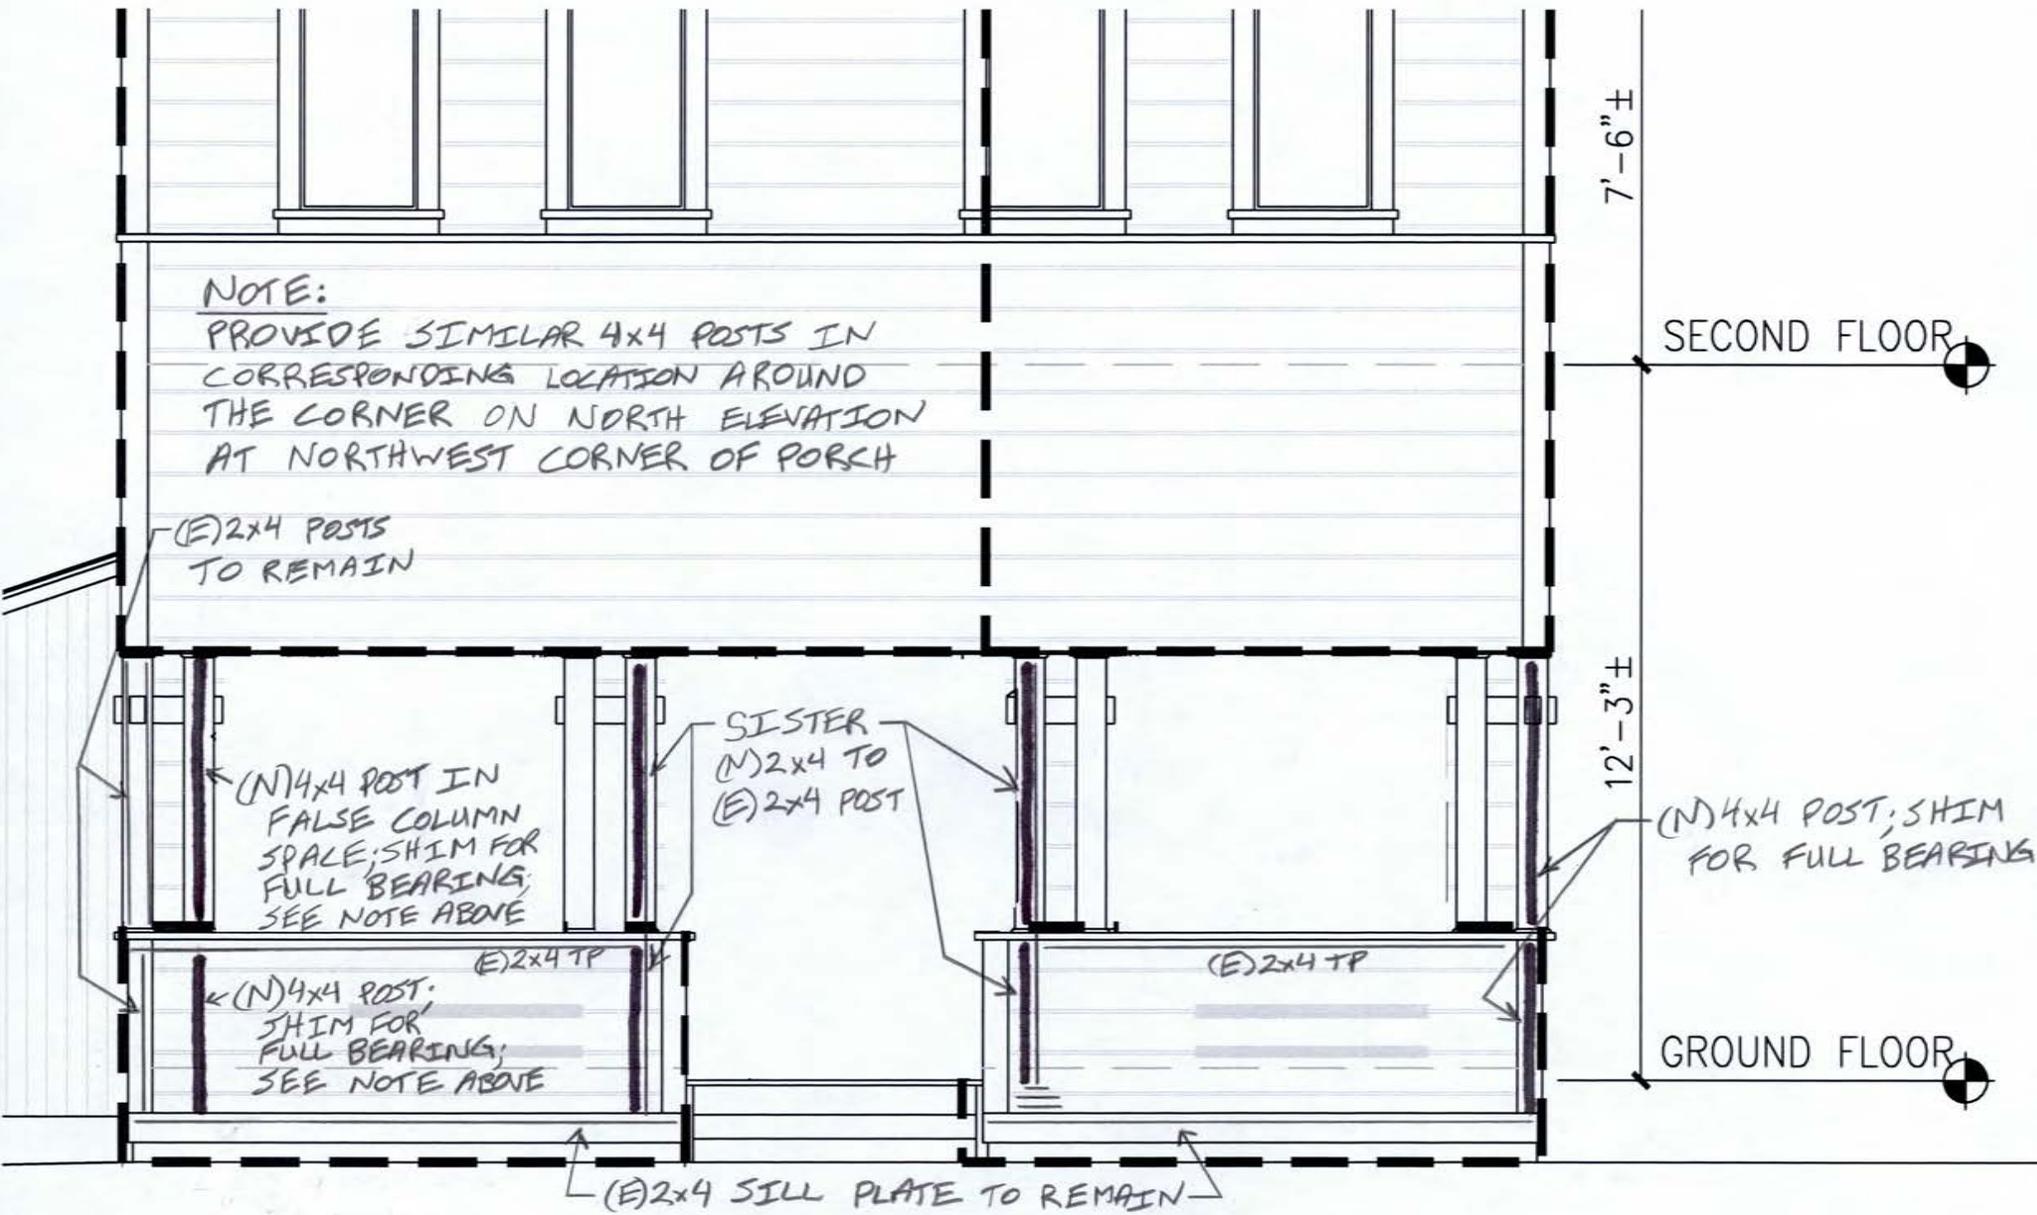
SSK
9

WEST ELEVATION - TEMPORARY IMMEDIATE REPAIRS
