master plan CARLSON PARK RIVERSIDE, CALIF.

CARLSON PARK 'A'

CITY OF RIVERSIDE

MASTER PLAN DEVELOPMENT
CITY OF RIVERSIDE
PARKS AND RECREATION DEPT.

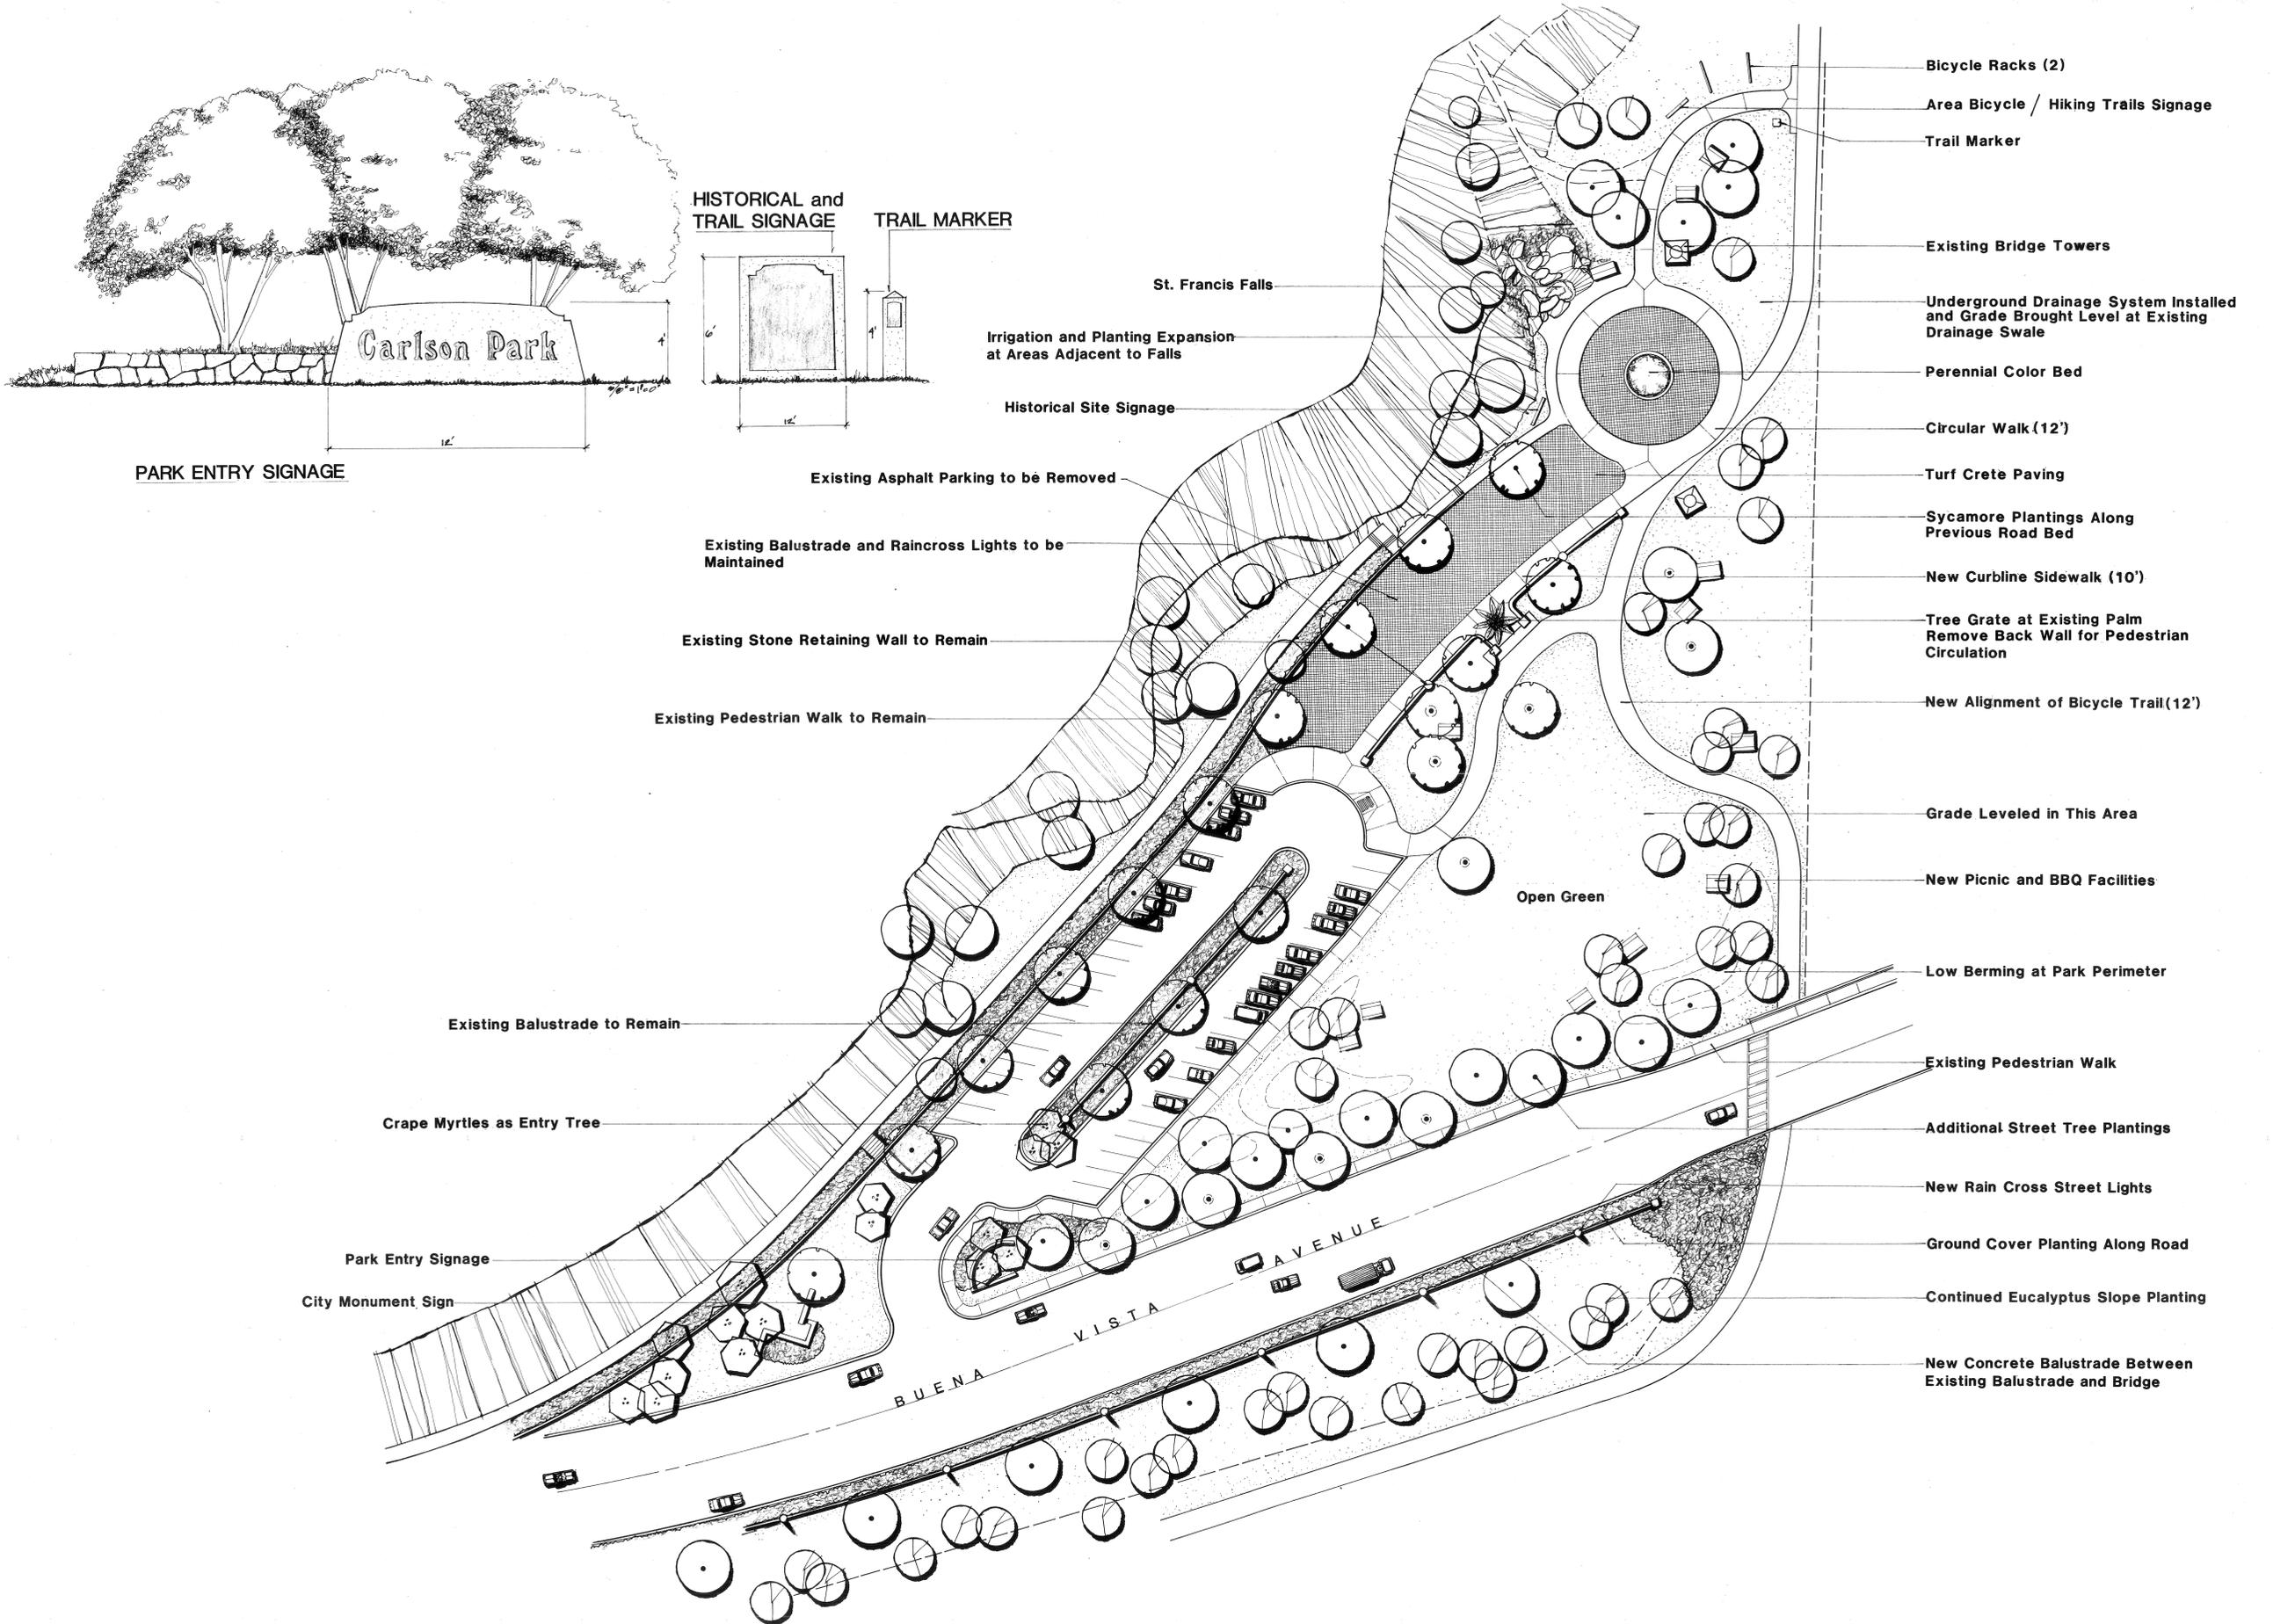
Existing Asphalt Parking to be Removed

Existing Balustrade and Raincross Lights to be Maintained

Existing Stone Retaining Wall to Remain

Existing Pedestrian Walk to Remain

Existing Balustrade to Remain

Crape Myrtles as Entry Tree

Park Entry Signage

City Monument Sign

Irrigation and Planting Expansion at Areas Adjacent to Falls

Historical Site Signage

St. Francis Falls

Open Green

- Bicycle Racks (2)
- Area Bicycle / Hiking Trails Signage
- Trail Marker
- Existing Bridge Towers
- Underground Drainage System Installed and Grade Brought Level at Existing Drainage Swale
- Perennial Color Bed
- Circular Walk (12')
- Turf Crete Paving
- Sycamore Plantings Along Previous Road Bed
- New Curbline Sidewalk (10')
- Tree Grate at Existing Palm Remove Back Wall for Pedestrian Circulation
- New Alignment of Bicycle Trail (12')
- Grade Leveled in This Area
- New Picnic and BBQ Facilities
- Low Berming at Park Perimeter
- Existing Pedestrian Walk
- Additional Street Tree Plantings
- New Rain Cross Street Lights
- Ground Cover Planting Along Road
- Continued Eucalyptus Slope Planting
- New Concrete Balustrade Between Existing Balustrade and Bridge
